ARCHAEOLOGICAL SURVEY OF BLUIE WEST 3, GAMATRON, ARTILLERY POINT AND CAMP CORBETT, KUJALLEQ KOMMUNE, SOUTH GREENLAND, 18-25 SEPTEMBER 2020

Report prepared by:

May 2021, Nuuk

Nunatta Katersugaasivia Allagaateqarfialu // Greenland National Museum and Archives

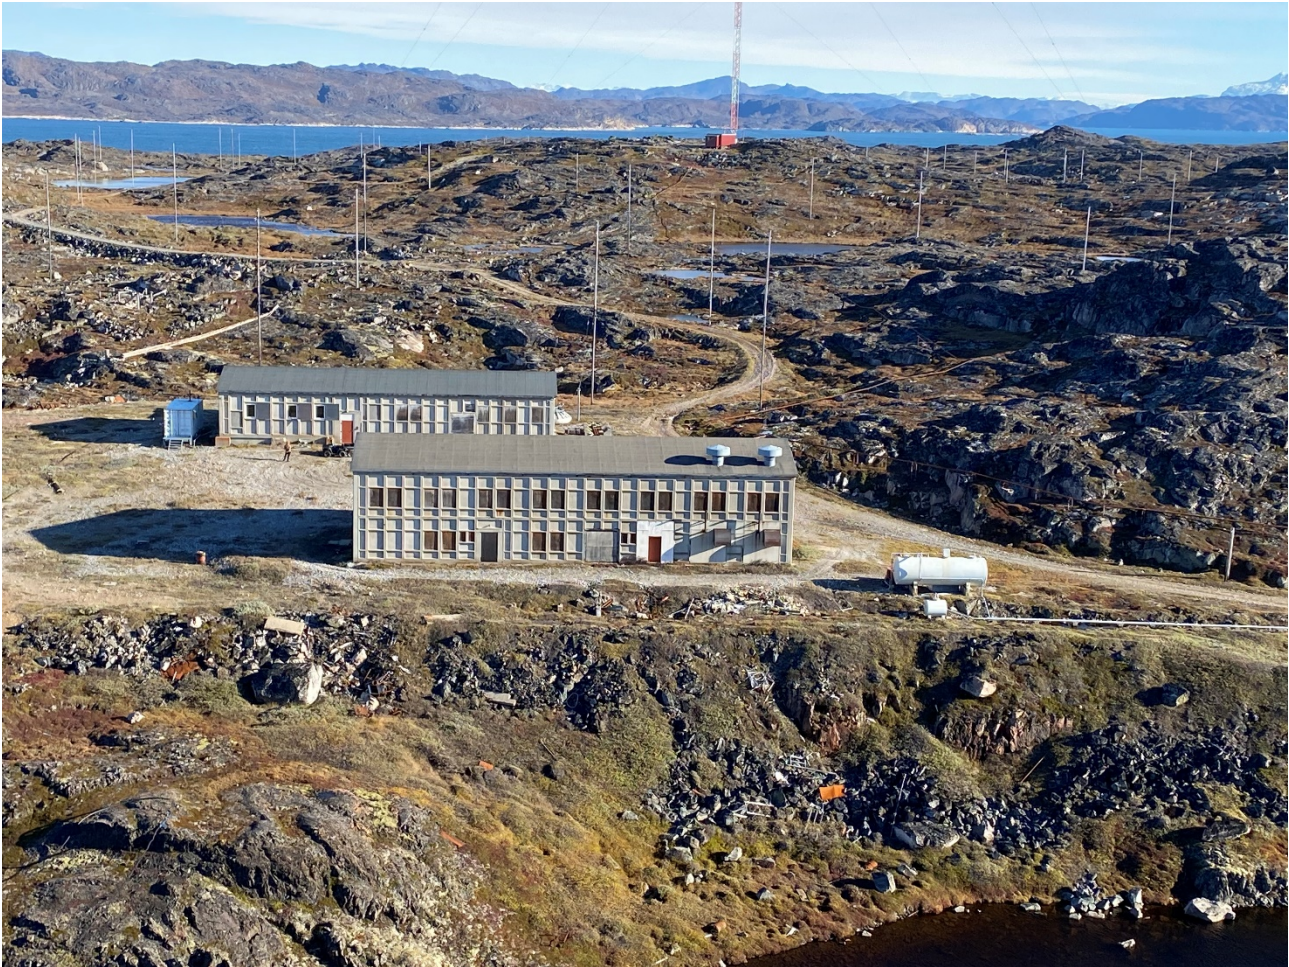
Fig. 11. B-447 in foreground and B-448 lying behind, facing north. A road leading to TELEPOST's large antenna and remnants of the masts that comprised the American NDB radio array can be seen in the background. Photo: Harmsen 2020, facing north.

Two concrete buildings are found on Simiutaq, located approximately .5 km west of the harbor. B-447 (with an area of 312 m²) served as staff quarters and a mess hall during the post-war period (Fig. 11). At the time of the site visit, B-447 mainly functioned as the housing for a diesel generator with the rest of the bottom floor used for various construction and building material storage. The upstairs had been gutted of all electrical, lighting and plumbing fixtures. B-448 is slightly larger than B-447, spanning an area of 388 m², originally functioned as a communication relay by the US Air Force, and appears to have been continually used since the American withdrawal from the island. At the time of the site visit the building providing accommodation to TELEPOST technicians and maintenance staff. The building contains three bedrooms, a kitchen, recreational room and shower and toilet. The eastern side of the building contains an office, workshop and a transmission room for KNR's medium wave radio, NAVAIR's beacon and the Aasiaat VHF coastal distress radio (MSI messages). Modern additions are found in connection with B-448 that include a shipping container on a raised steel platform and large wooden shed on the north side of the building.

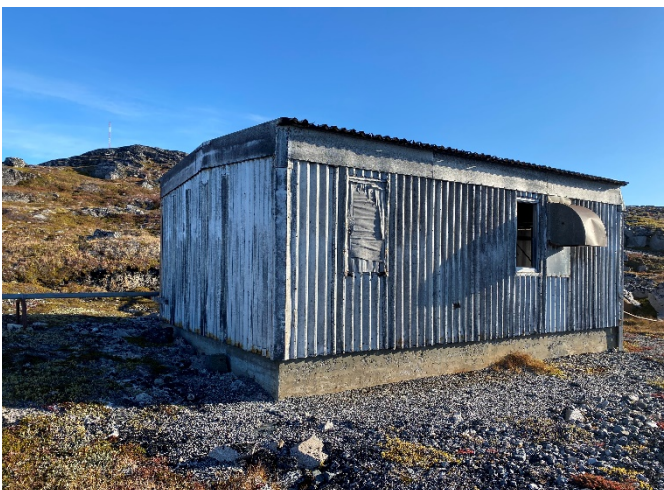
Fig. 13. B-450, facing northeast. Photo: Harmsen 2020.

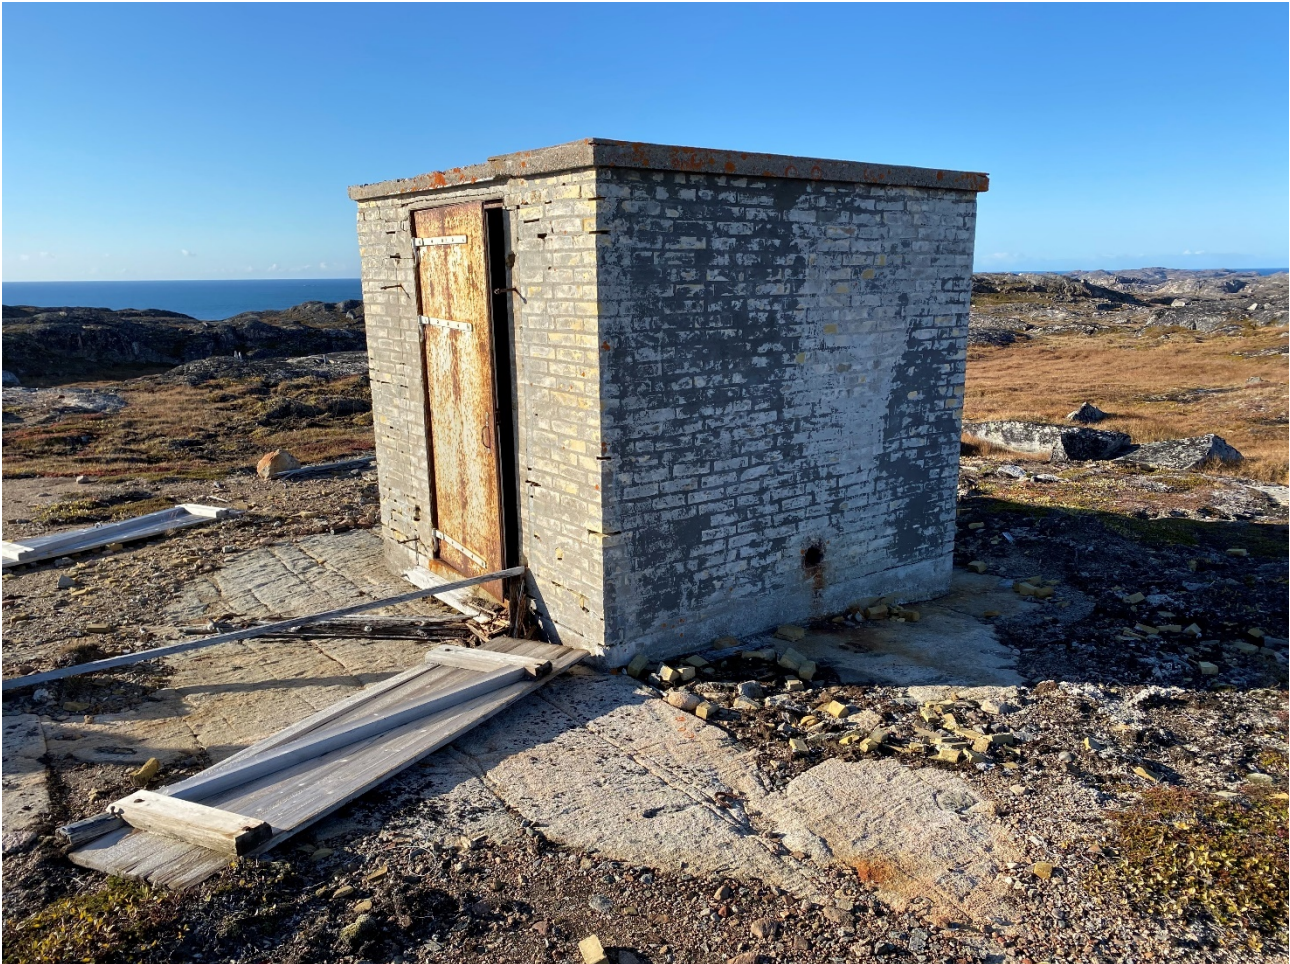
Fig. 14. B-451, antenna adapter housing, facing northwest. Photo: Harmsen 2020.

Located approximately 100 m to the north of B-451 is a small flat-roofed, brick and mortar structure that at one time served as the NDB's antenna adapter housing (Fig. 14 & Fig. 15). A large, pyramid-shaped cement pylon is found on the east side of the building, that would have functioned as a mast anchor to an antenna. The building is currently not in use and exact year of construction unknown.

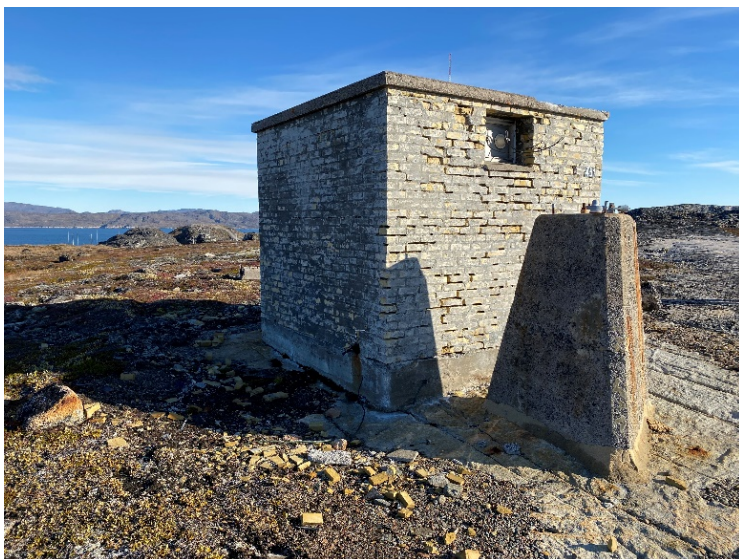
Fig. 15. B-451, the former NDB antenna adapter housing along with a precast cement pylon that served as a mast anchor (foundation element F008), facing southeast. Photo: Harmsen 2020.

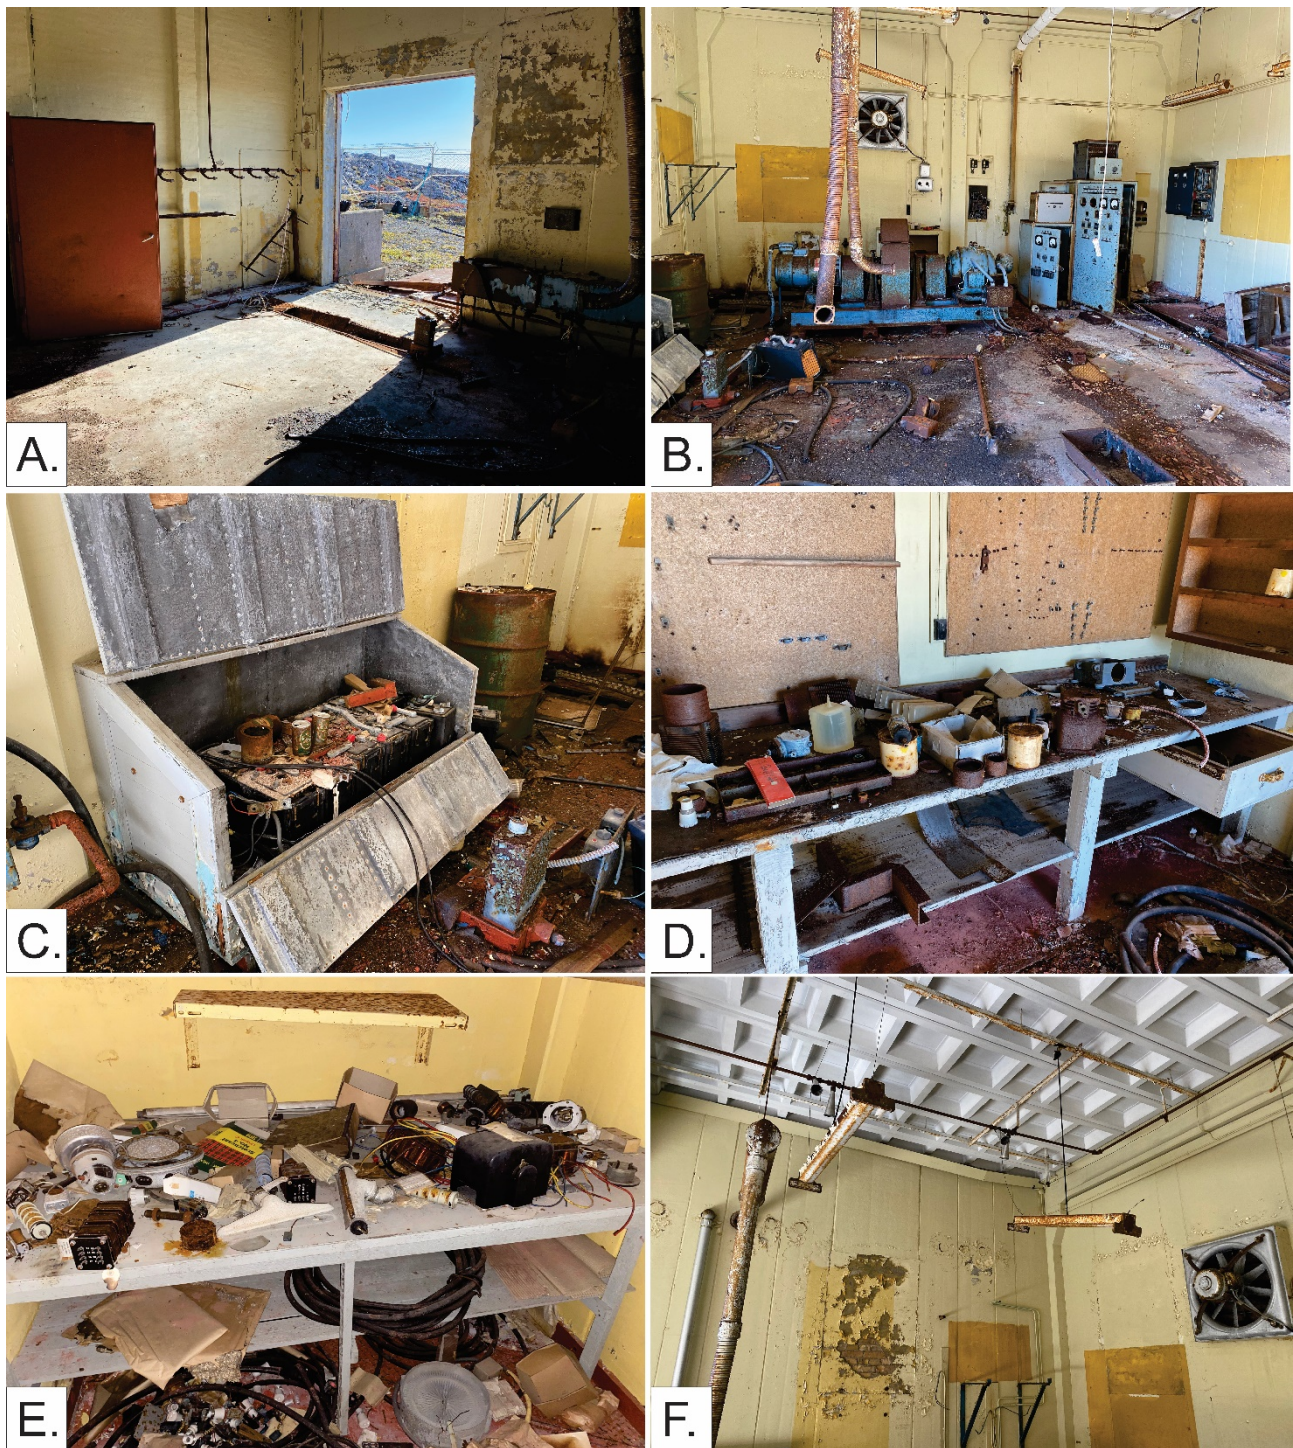
Fig. 18. (A.) The front door has fallen at B-452 leaving the inside main room exposed to the elements; (B.) An electrical alternator and AC regulator found against the southern wall of the main room. (C.) Empty beer cans, paint cans and other debris resting on a battery unit found in the main room; (D.) Workshop table in the main room; (E.) Table found in storage room with various pieces of discarded rubbish and electrical components; (F.) Ceiling of the main room with piping, fan vent and hanging fluorescent lighting fixtures.

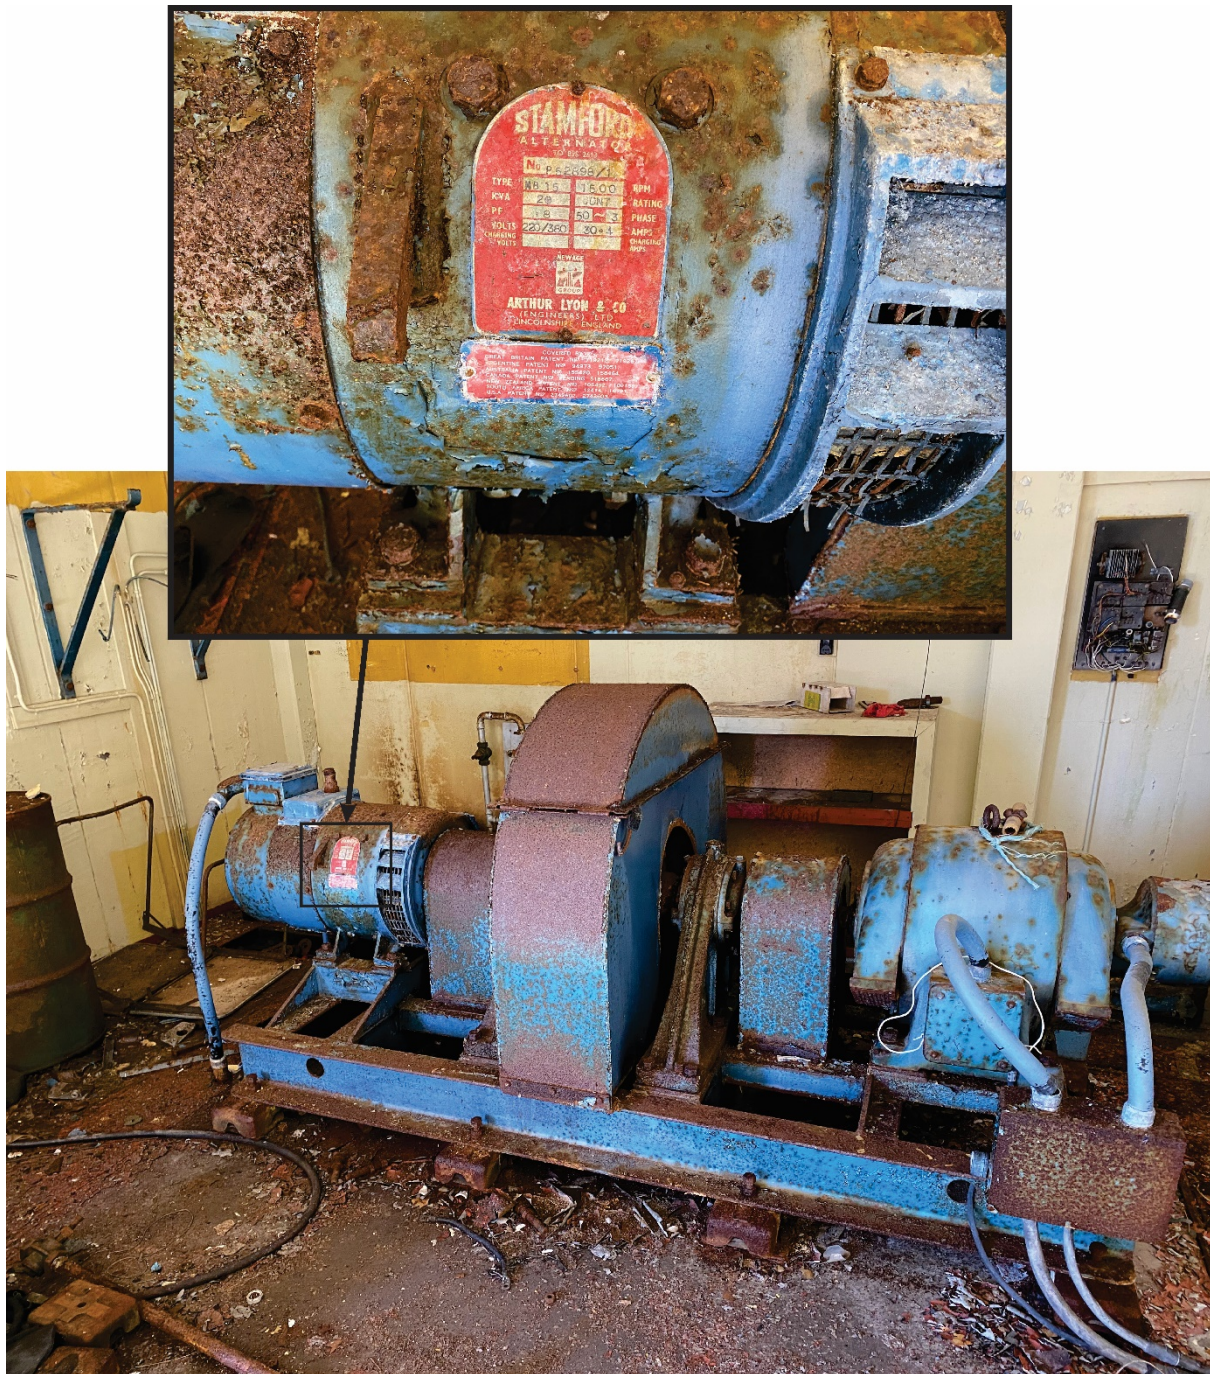
Fig. 19. Stamford Motors alternator, model NB15 produced by Arthur Lyon & Co. Engineers LTD of Lincolnshire England, found in the main room of B-452. Photo: Harmsen 2020.

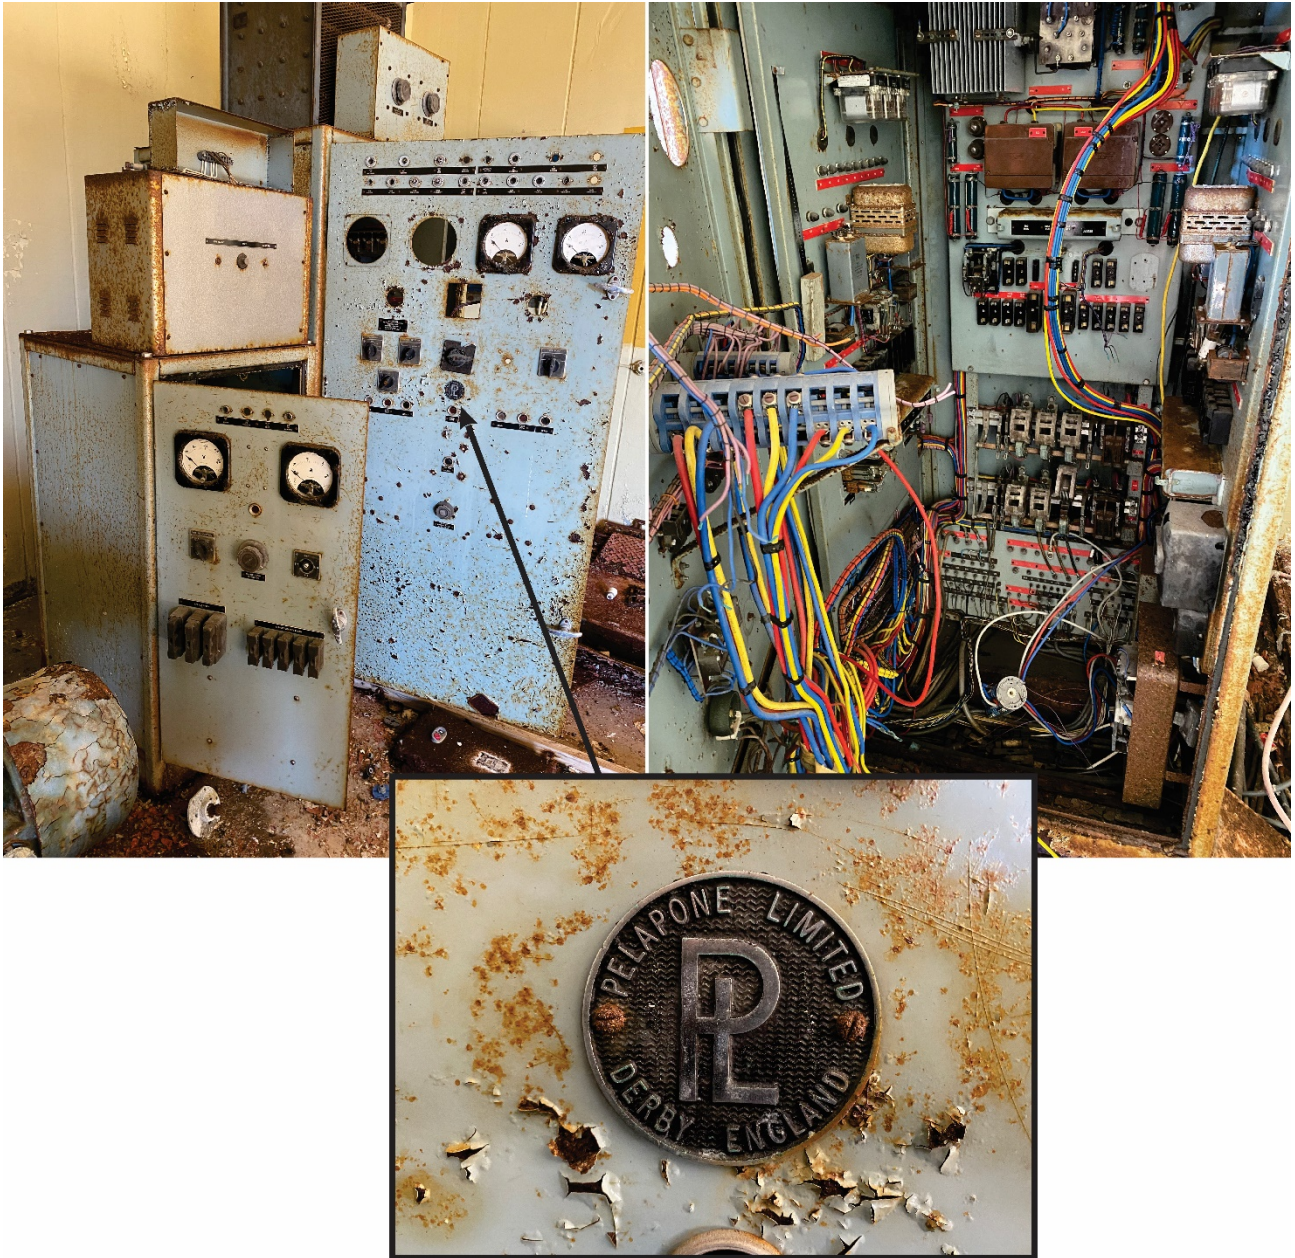
Fig. 20. AC field regulator produced by Pelapone Limited, Derby England. A marker's plate is found on the front panel of the larger uof the two components. Photo: Harmsen 2020.

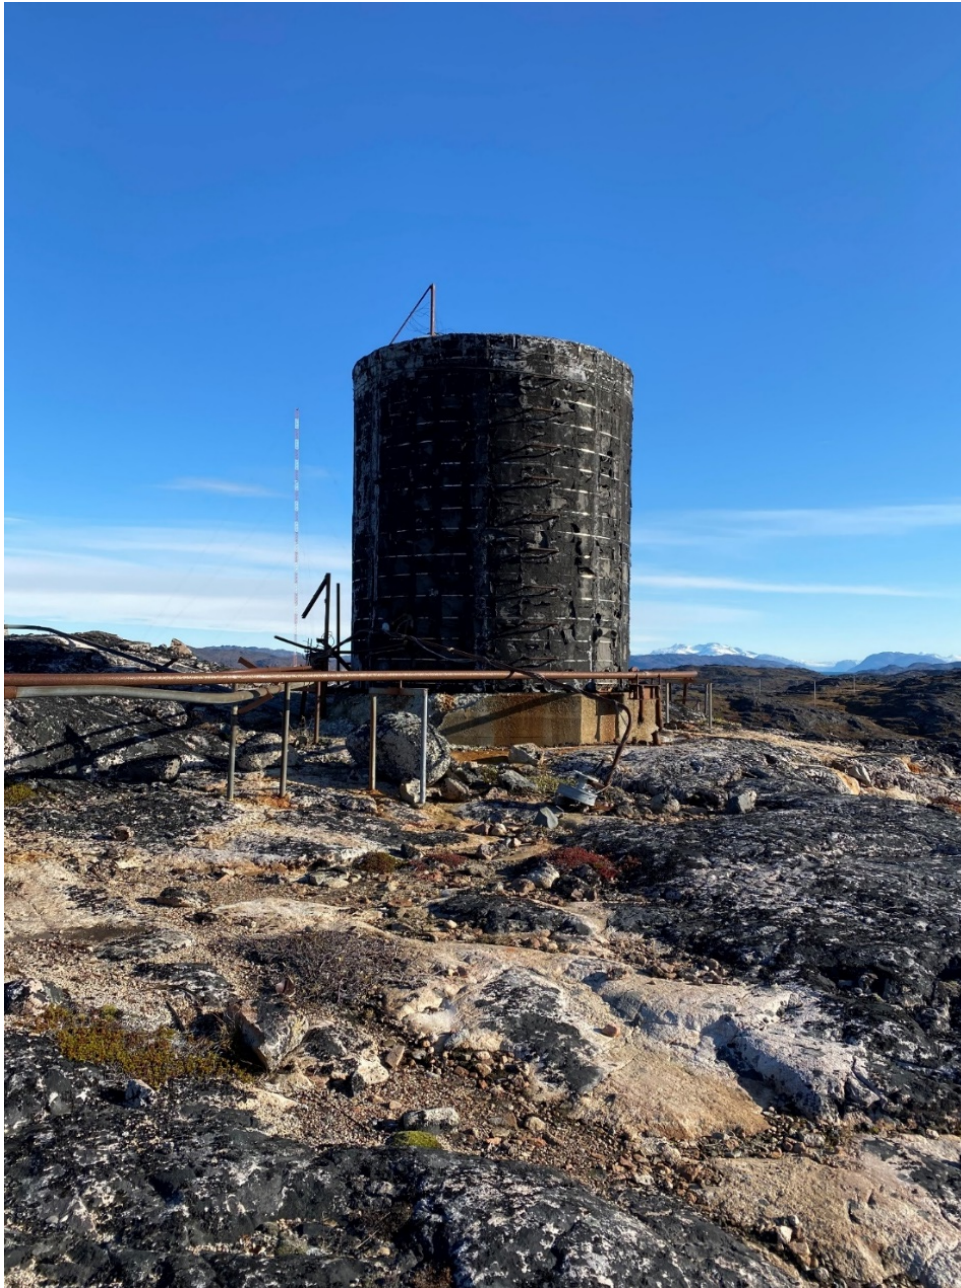
Fig. 21. The water tower on Simiutaq, facing north. Photo: Harmsen 2020.

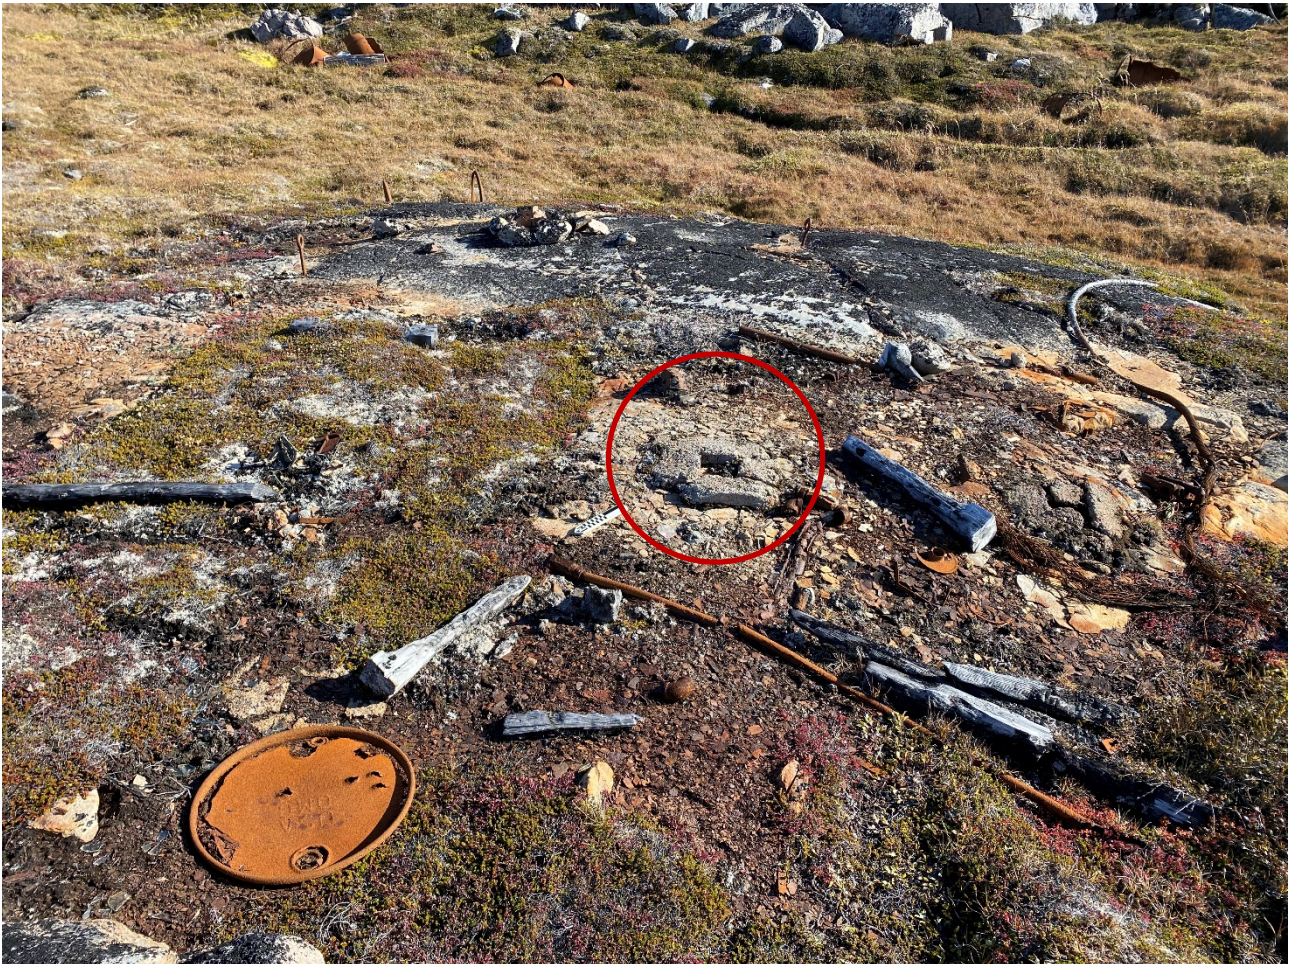
Fig. 24. Remains of F005, identified by the presence of two parallel rows of poured concrete post molds resting on bare rock. The red circle shows the most visible remnant of the six post molds. Numerous other types of debris from the US Army are found on site. Photo: Harmsen 2020, facing east.

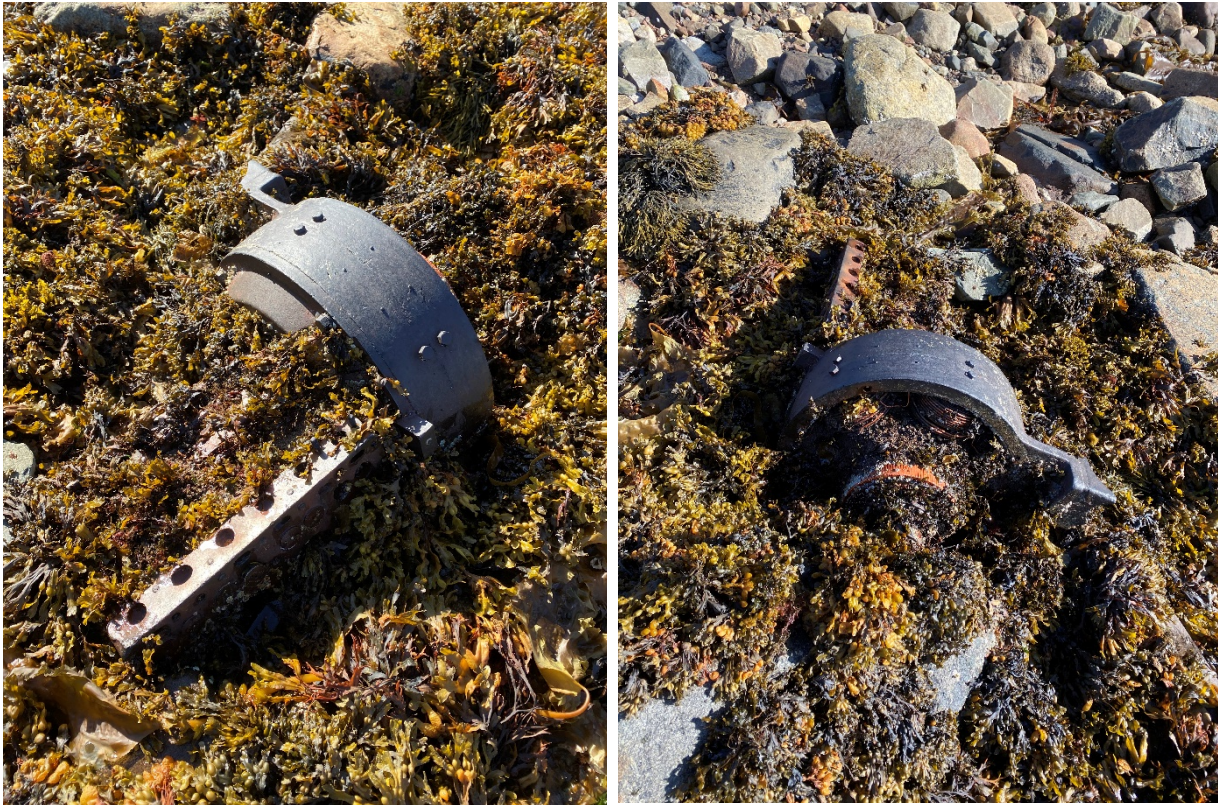
Fig. 25. Partial remains of an electrical generator armature and casing found covered in sea wrack in the intertidal zone of the beach, next to F005. Exact make and model of the generator is unknown but could be a PE-75-(*) power unit family, a generator used frequently by the US Army Signal Corp during WWII.

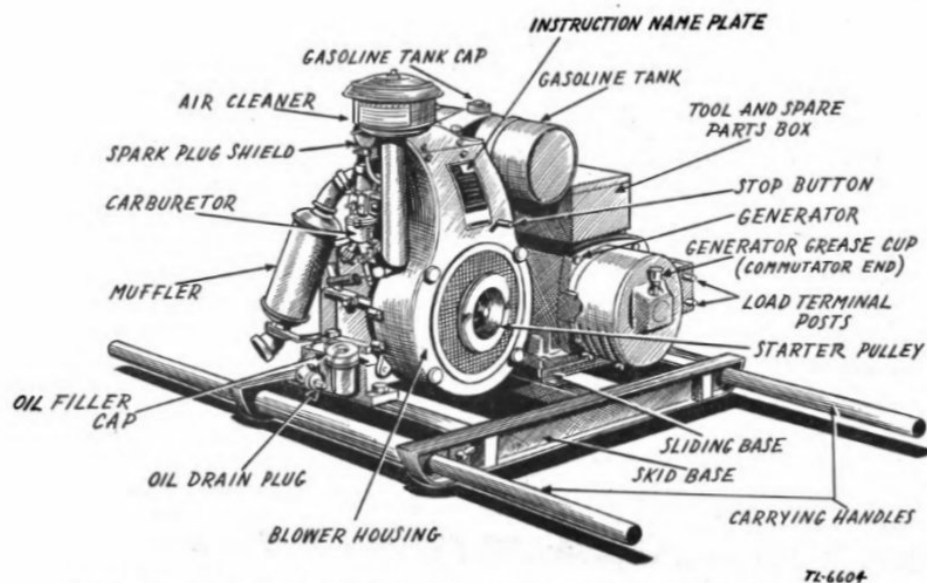
Fig. 26. Schematic diagram of a PE-75 power unit. The generator could produce 2.5000 watts of electricity and was a commonly employed by the US Army during WWII (U.S. War Department 1943:2, Figure 1, U.S. Air Force 1957/158).

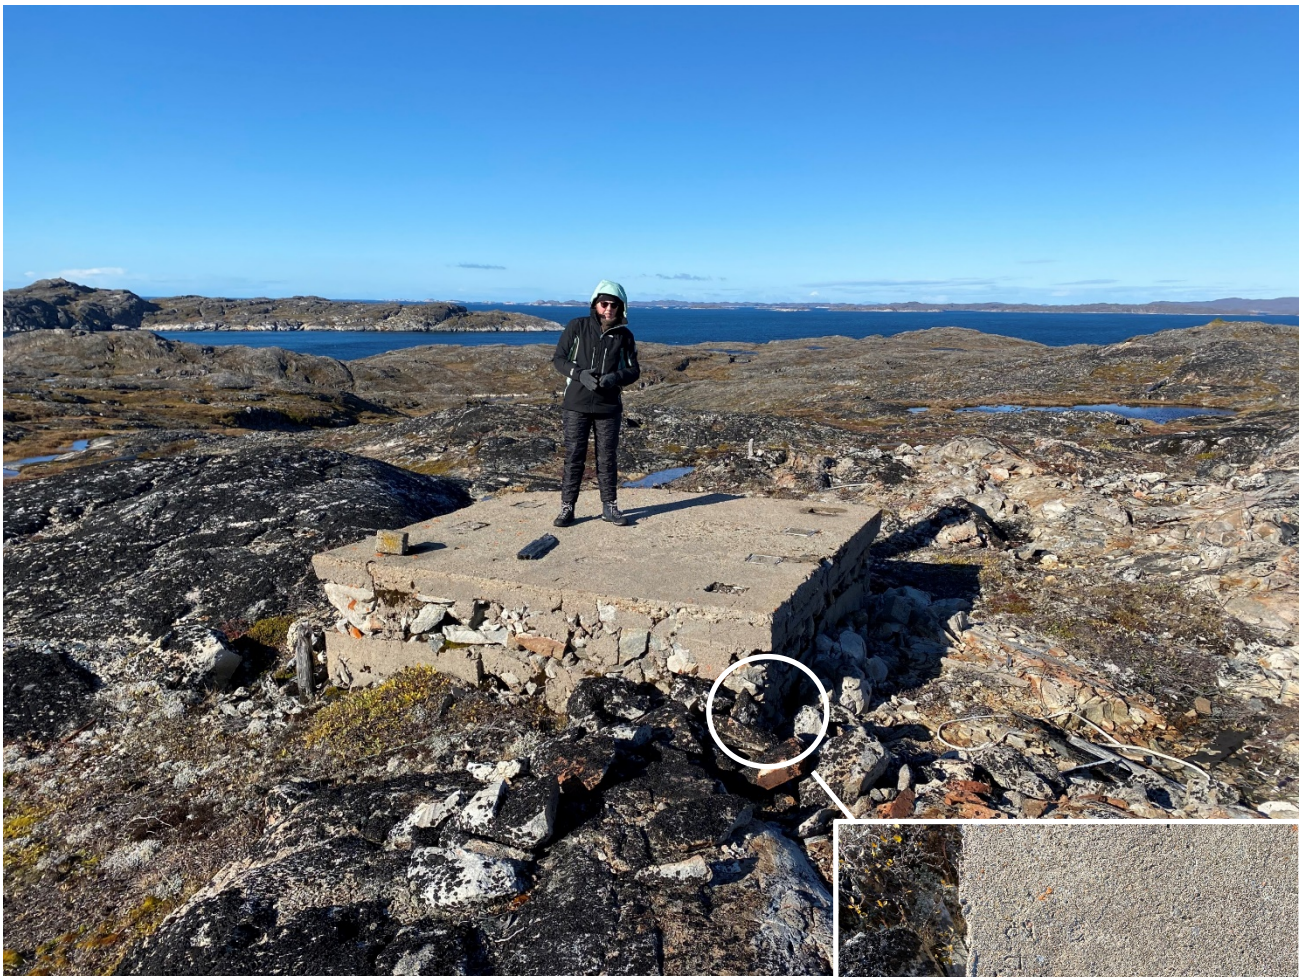
Fig. 27. F010 is located 210 m to the west of B-452 and is believed to be the foundation platform for the former VHF/UHF transmitter/receiver shack on Simiutaq. Kristiansen stands on the platform for scale. An inscription in the cement is found in the northeast corner of the platform. Photo: Harmsen 2020, facing west.

- The poured concrete foundation (F010) found at 60.68618°, -46.60538° on Simiutaq, BW-3, with the inscription “G.S. W.W. 42,” should remain undisturbed. The foundation poses no threat to the environment and possesses significant historic value with its unique inscription.

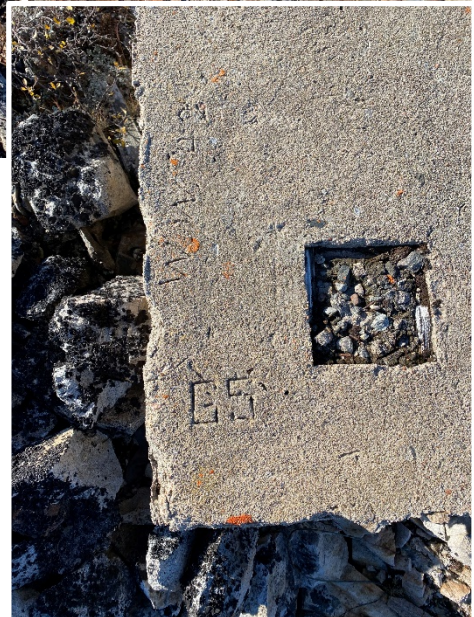
Fig. 28. The initials 'G.S.' and 'W.W. 42' are found in the northeast corner of the concrete platform. Photo: Harmsen 2020.

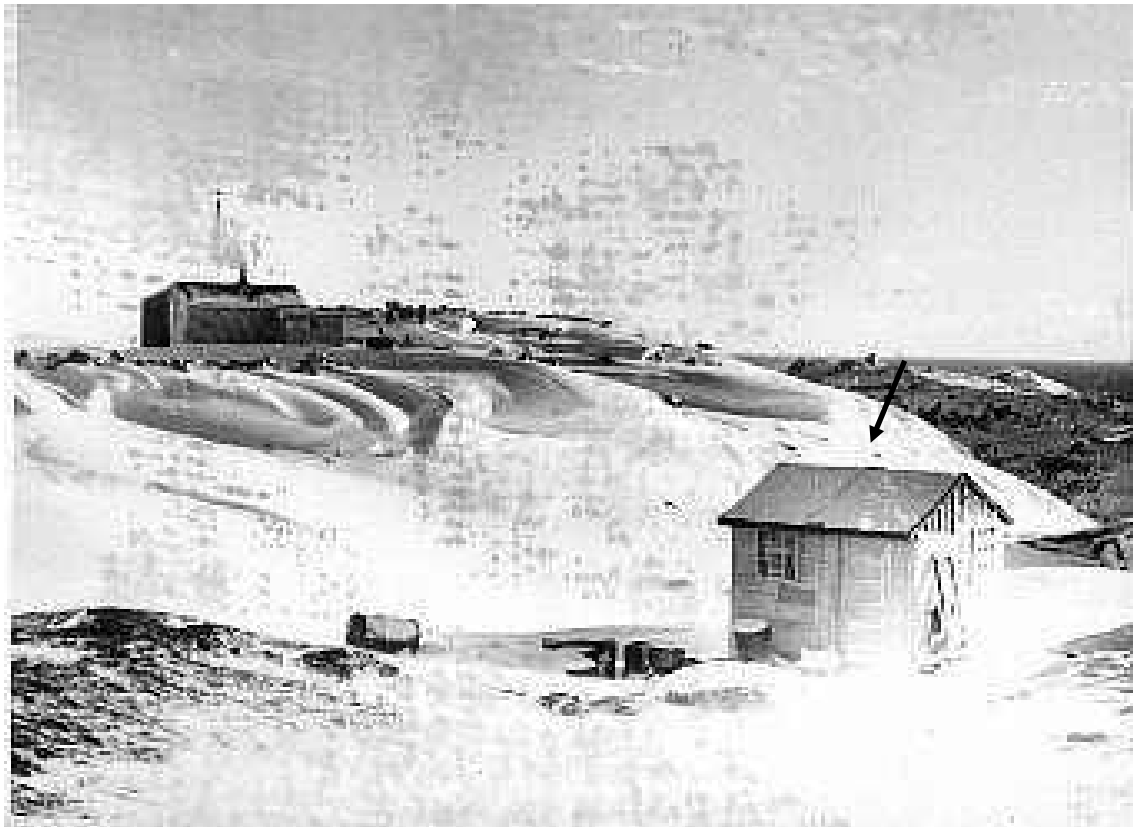
Fig. 29. Arrow pointing to the VHF/UHF Transmitter/Receiver shack (F010), facing southeast. The NDF beacon (B-452) is seen on the hill seen in the distance. Photo: Jim Chase, date unknown. Source: <https://www.creativehwy.net/jcstott/chase/bw3rcn.html>.

about the former structure except it would have function in tandem with the operations taking place at the nearby NDF beacon. The surrounding area is littered with broken electrical components and ceramic insulators, and other rubbish burned on site.

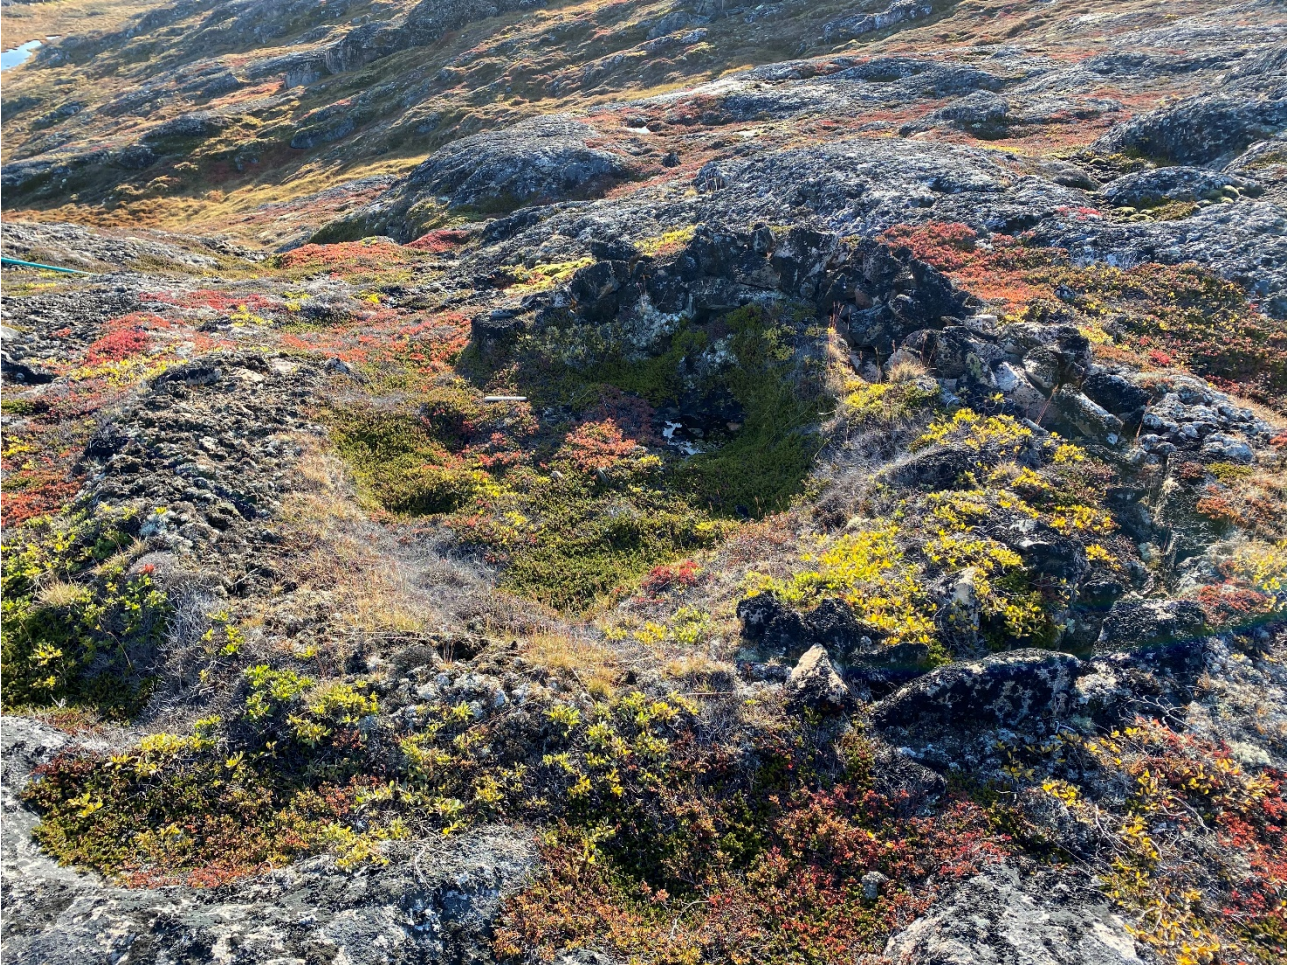
Fig. 35. NKAH 5680, a cylindrical stone and turf ruin found on the elevated rocky overlook above the harbor. Photo: Harmsen 2020, facing southwest.

- No disturbing activity of any kind can take place within 20 m of the two ancient sites of NKAH 5680 and NKA 5681 on Simiutaq. Both sites and all their associated components are protected under the Heritage Act (Inatsisartutlov nr. 5 af 12. juni 2019).

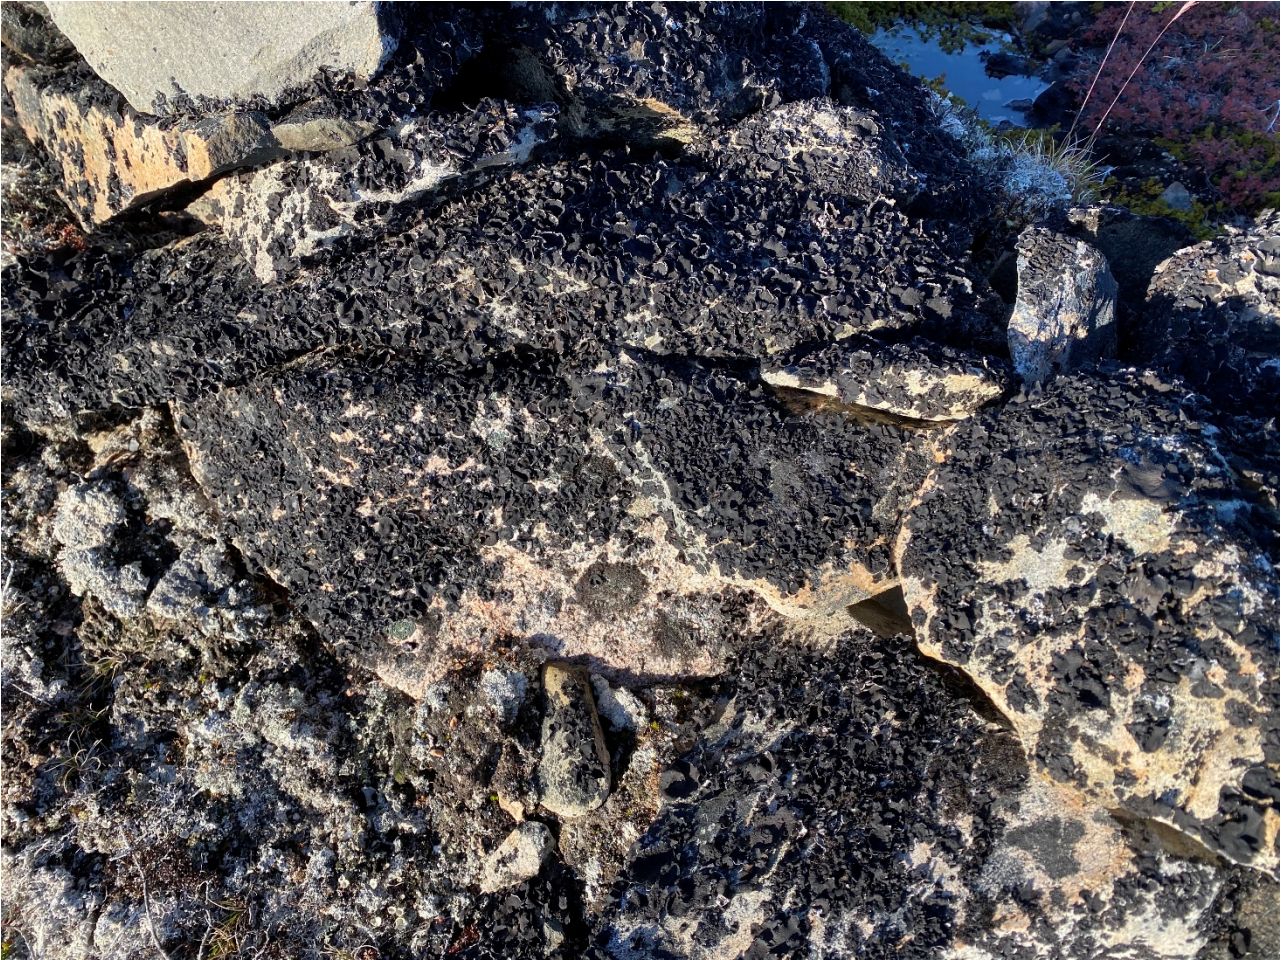
Fig. 39. Dense and unbroken overgrowth of lichen species *Pseudephebe minuscula* and *Rhizocarpon geographicum* found on stones from the western wall of NKAH 5680 are suggestive of the antiquity of the feature. Photo: Harmsen 2020.

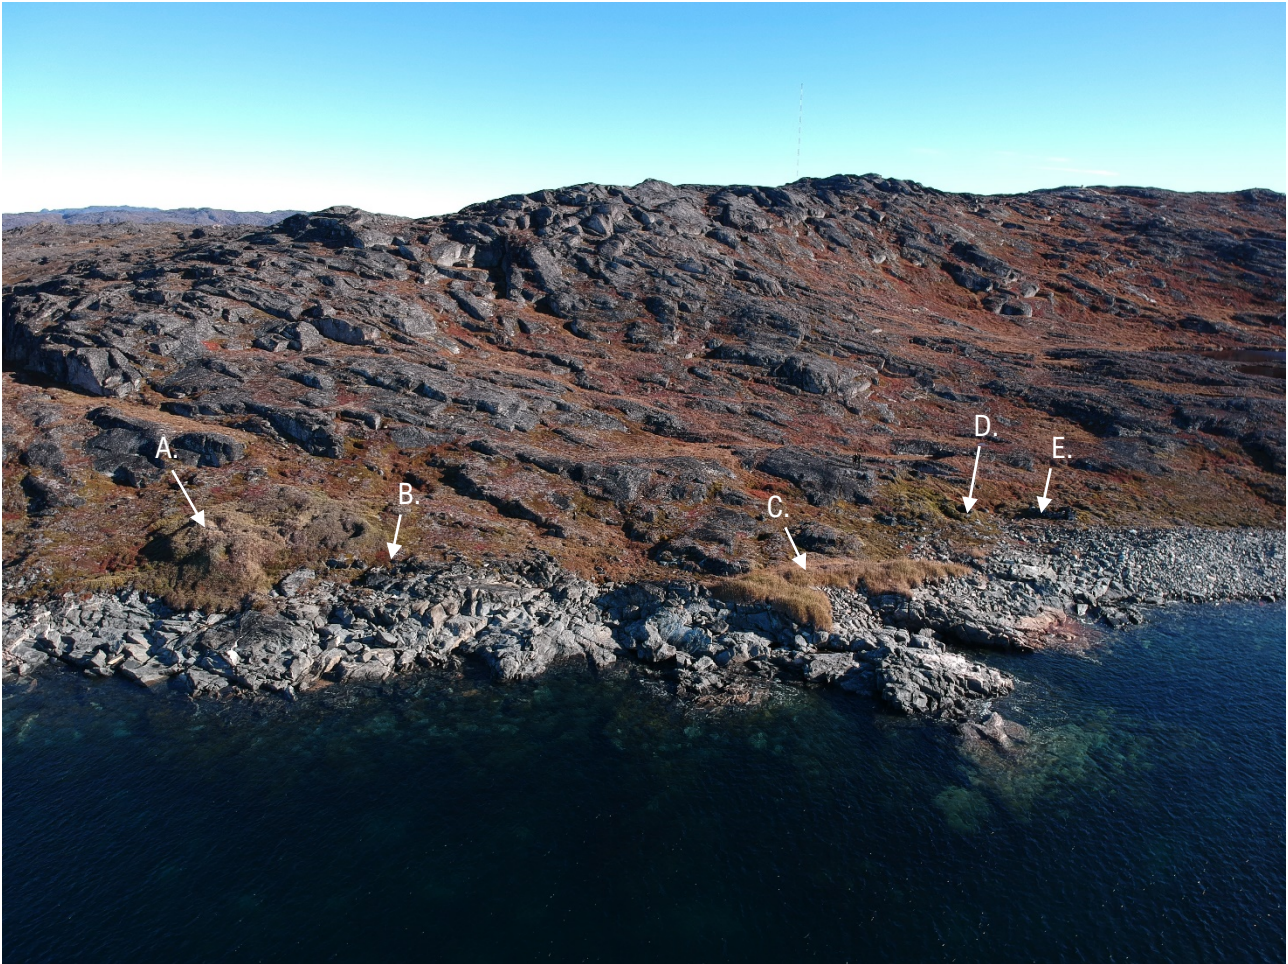
Fig. 40. NKAH 5681 ("Ditte's Site"), view toward the north. The site possesses five distinct archaeological elements that include both Norse and Thule luit feature types: (A.) Inuit winter house; (B.) rectangular stone feature; (C.) Norse dwelling ruins; (D.) 3x circular pit mounds; (E.) Norse animal pen. Photo: Harmsen, 2020.

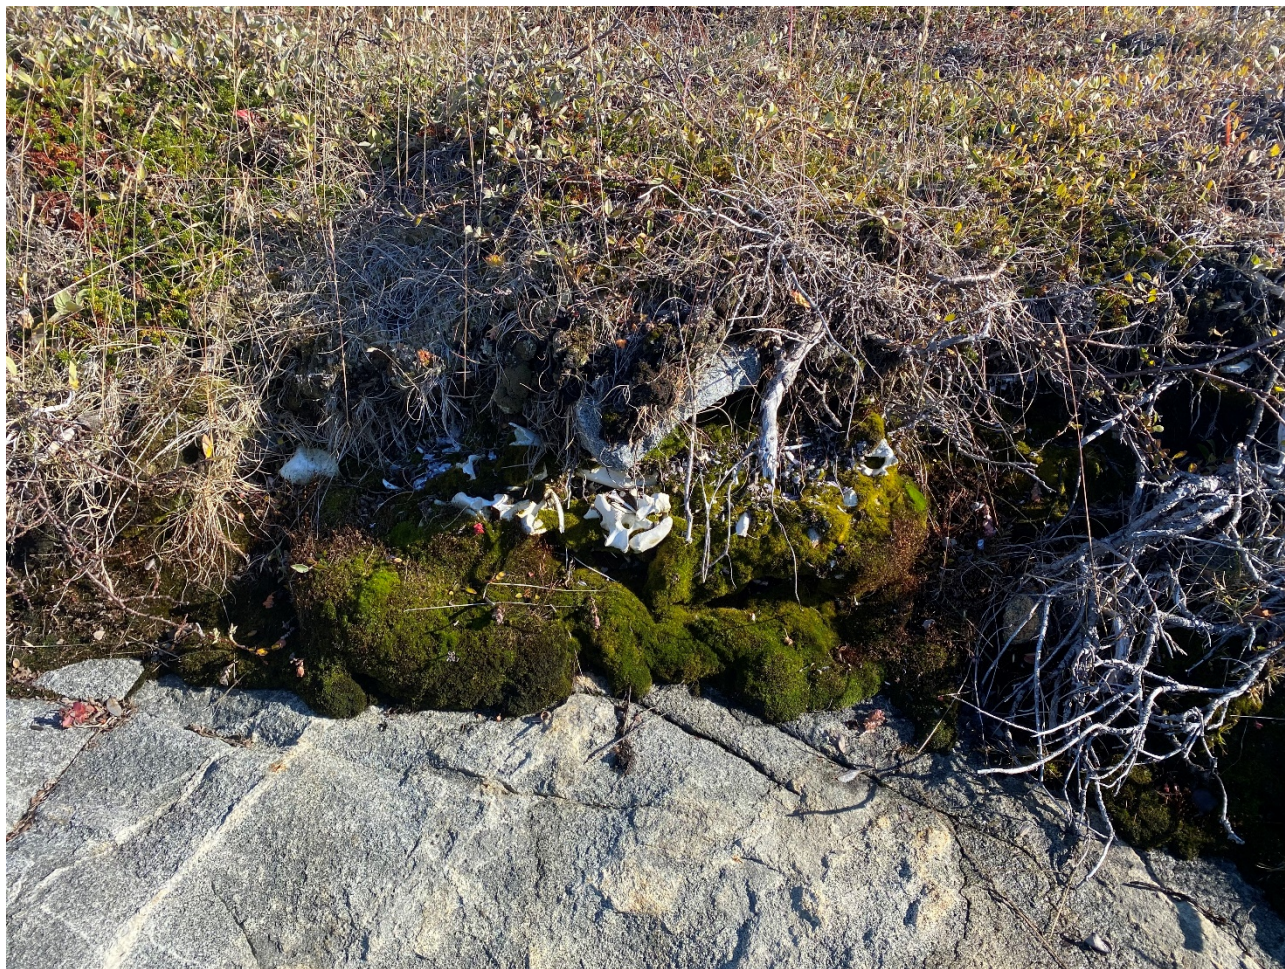
Fig. 44. Evidence of the well-preserved midden connected to the winter house, feature A. The midden is found below the house toward the rocky shoreline. The midden is stable with only some faunal materials emerging in a few isolated spots.

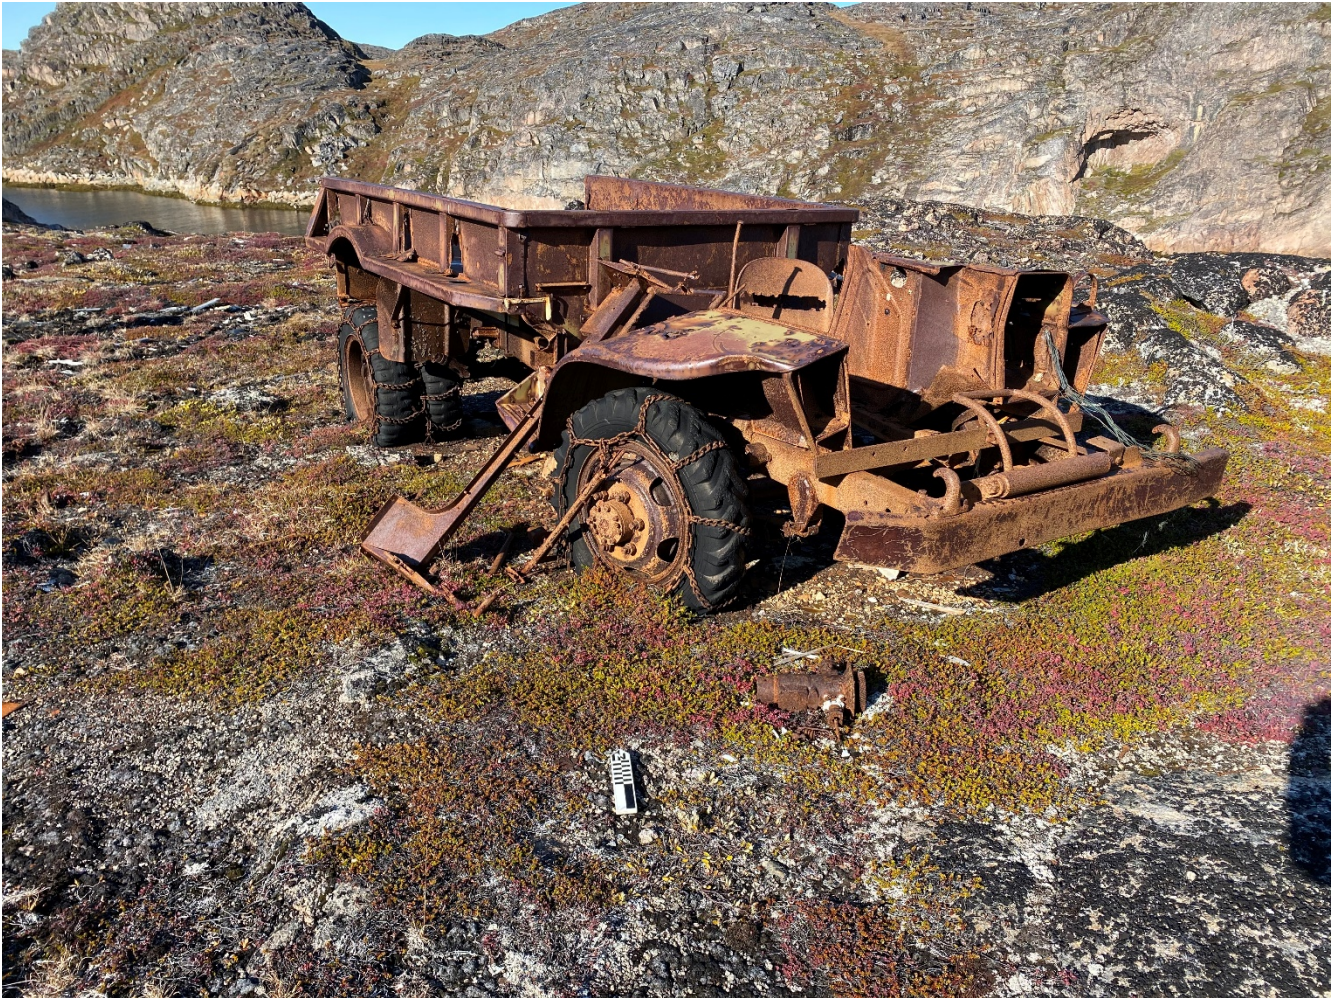
Fig. 55. Remains of a Ford G-622 GTB Burma Jeep at Gamatron. Photo: Harmsen 2020, facing north.
