ARCHAEOLOGICAL SURVEY OF BLUIE WEST 3, GAMATRON, ARTILLERY POINT AND CAMP CORBETT, KUJALLEQ KOMMUNE, SOUTH GREENLAND, 18-25 SEPTEMBER 2020

Report prepared by:

May 2021, Nuuk

Nunatta Katersugaasivia Allagaateqarfialu // Greenland National Museum and Archives

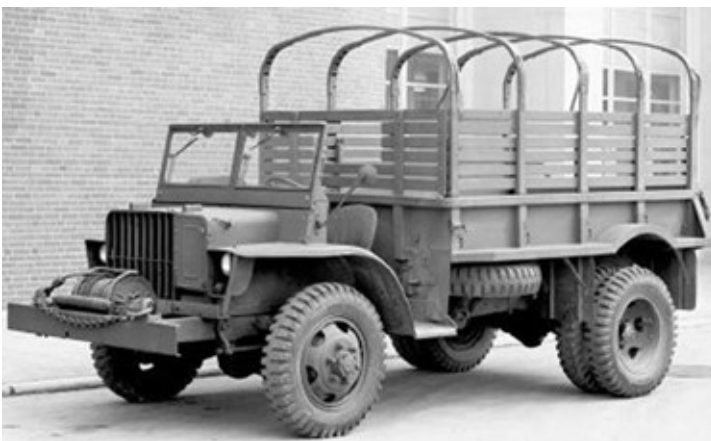
Fig. 56. Ford GTB G-622 Burma Jeep. Source: <https://tvd.im/land-systems/2413-ford-gtb-g-622-burma-jeep.html>.

Weighing 7250 lbs., the G-622 GTB vehicles were typically produced with a 10,000 lb. Gar Wood or Braden front mounted winch and painted "Ocean Gray" for all Navy contracts. All GTBA models had dual rear wheels as can clearly be seen in Fig. 56. The cowl covering the engine would have separated the cab area, with the passenger seat being a light metal frame, which faced the driver, and could be enclosed by raising the windshield and installing a canvas top. The truck could be equipped with troop seats and bows for a canvas cover (Estrella Warbirds Museum 2021).

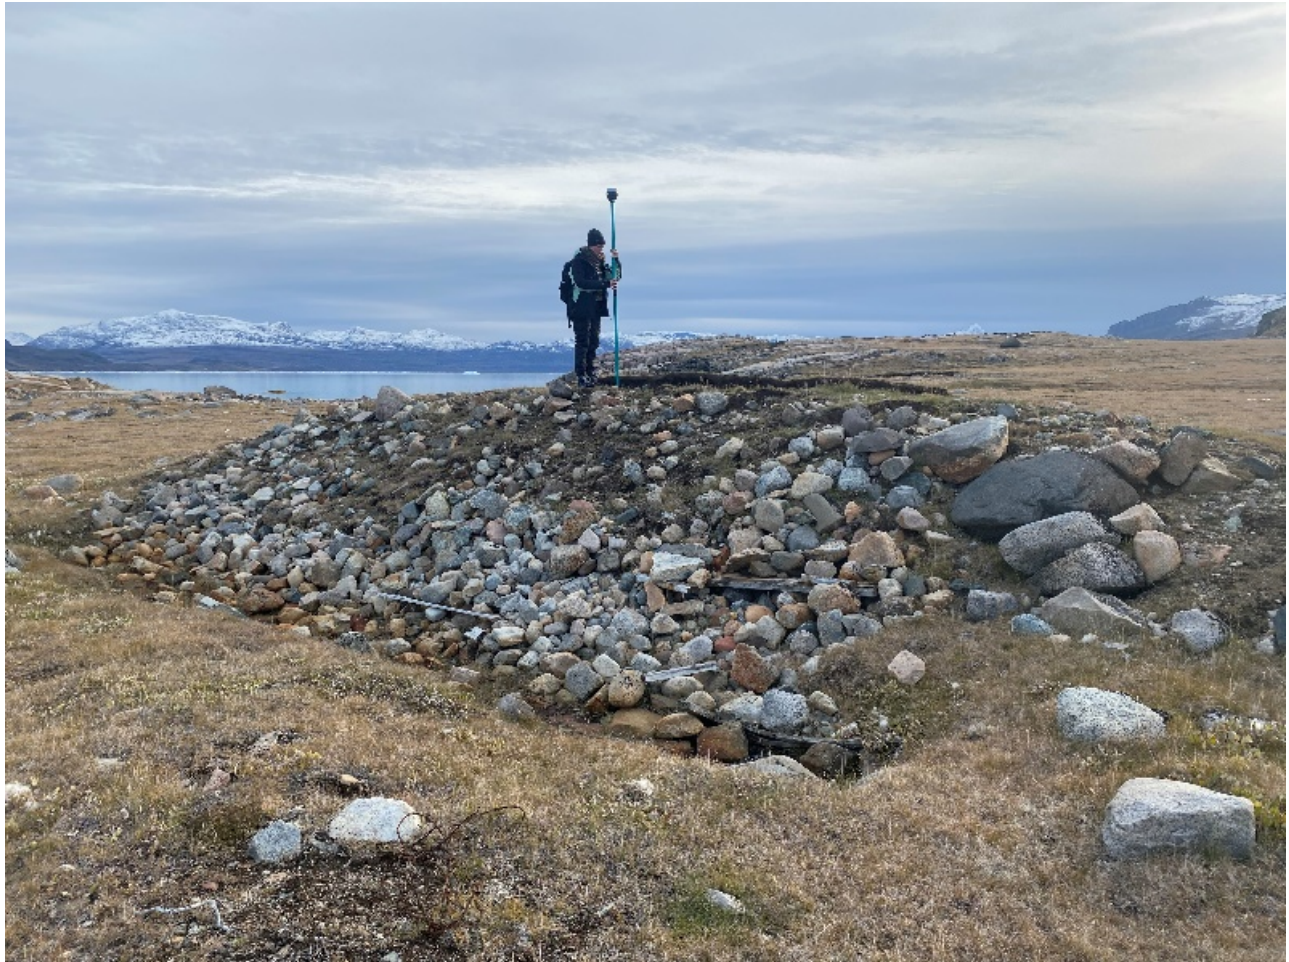
Fig. 60. A stone berm (D009) and trench feature at Artillery point, facing south. Kristiansen shown in the photo for scale. Photo: Harmsen 2020.

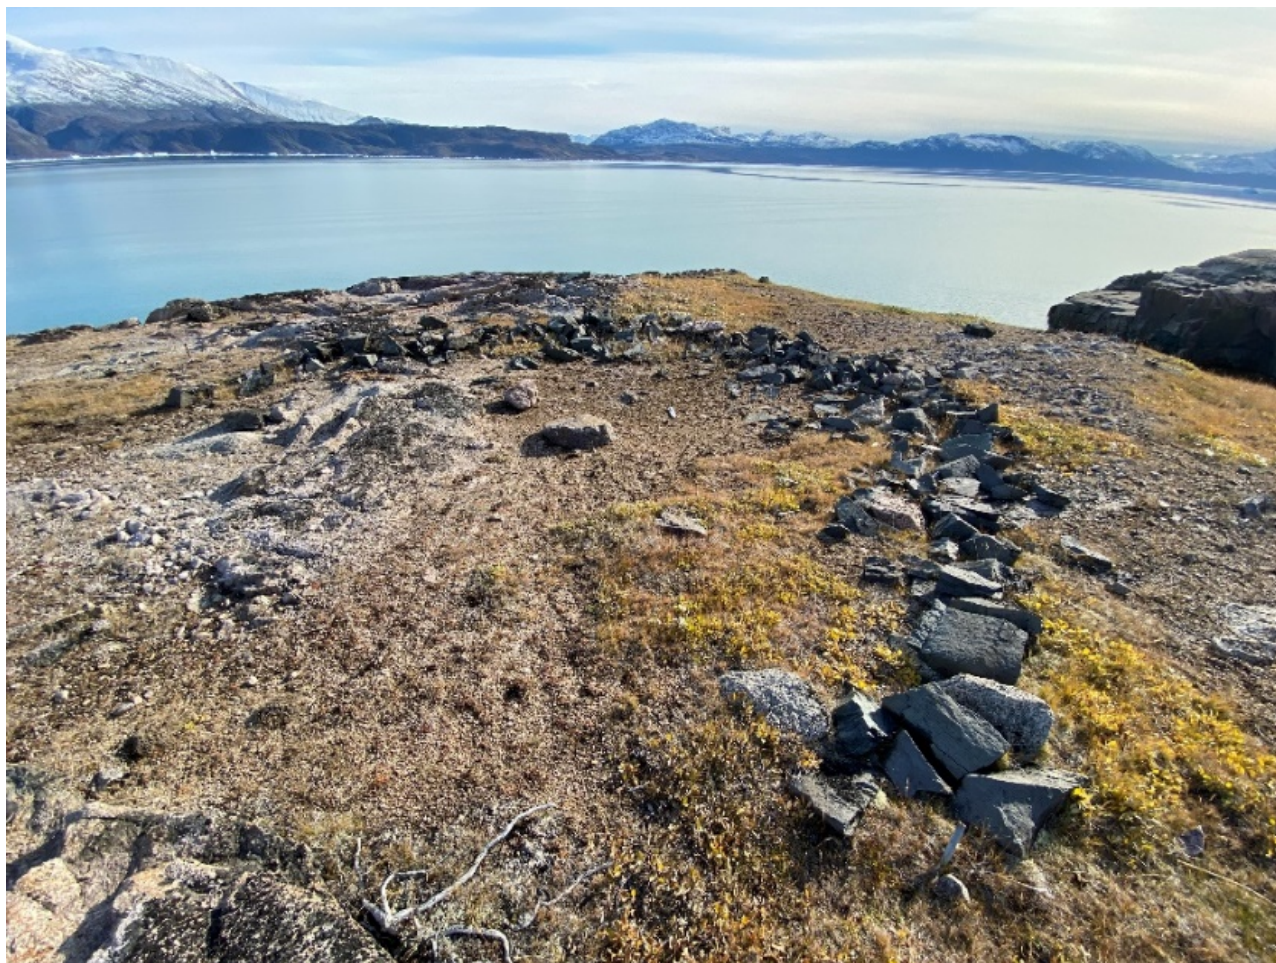
Fig. 62. Feature D001 at Artillery Point, facing southeast. Photo: Harmsen 2020.

Located on the extreme southern periphery of the camp, D001 (Fig. 62) is a low-lying crescent-shaped feature formed of piled cobbles on a flat rocky overlook that provides a clear viewshed of the Tunilliarfik fjord to the south and east. The feature measures approximately 8m across at its widest point and 5m deep (Fig. 63). Given that D001 appears to not serve any functional stabilizing purpose, it is unclear whether its original design was merely intended as a marker for the positioning of a smaller mobile artillery weapon or demarcated the position of a temporary structure or lookout post used in the surveillance of the surrounding fjord.

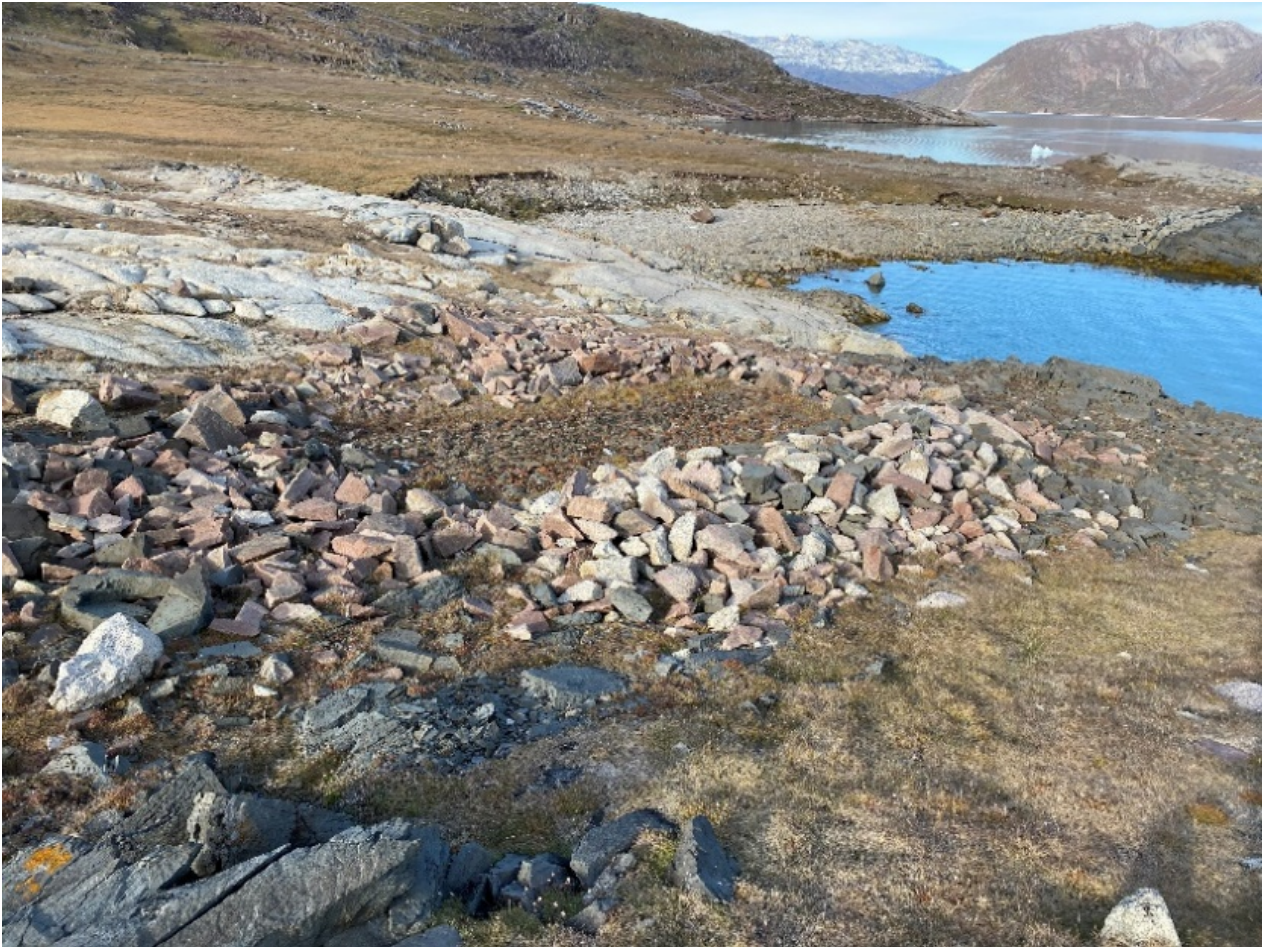
Fig. 64. Feature D002 at Artillery Point, facing north. Photo: Harmsen 2020.

Feature D002 (Fig. 64) comprises a pile of loosely piled cobbles measuring 13m in length and a 10,5m at its widest point. An almost perfect rectangular clearing is found in the interior of the feature measuring 6,8m x 3,3m. It is presumed that the stones were used to secure and buttress a structure or container now removed (Fig. 65). The feature could have likely been an ammo dump or munitions cache for the nearby artillery positions of D004, D005 and D006.

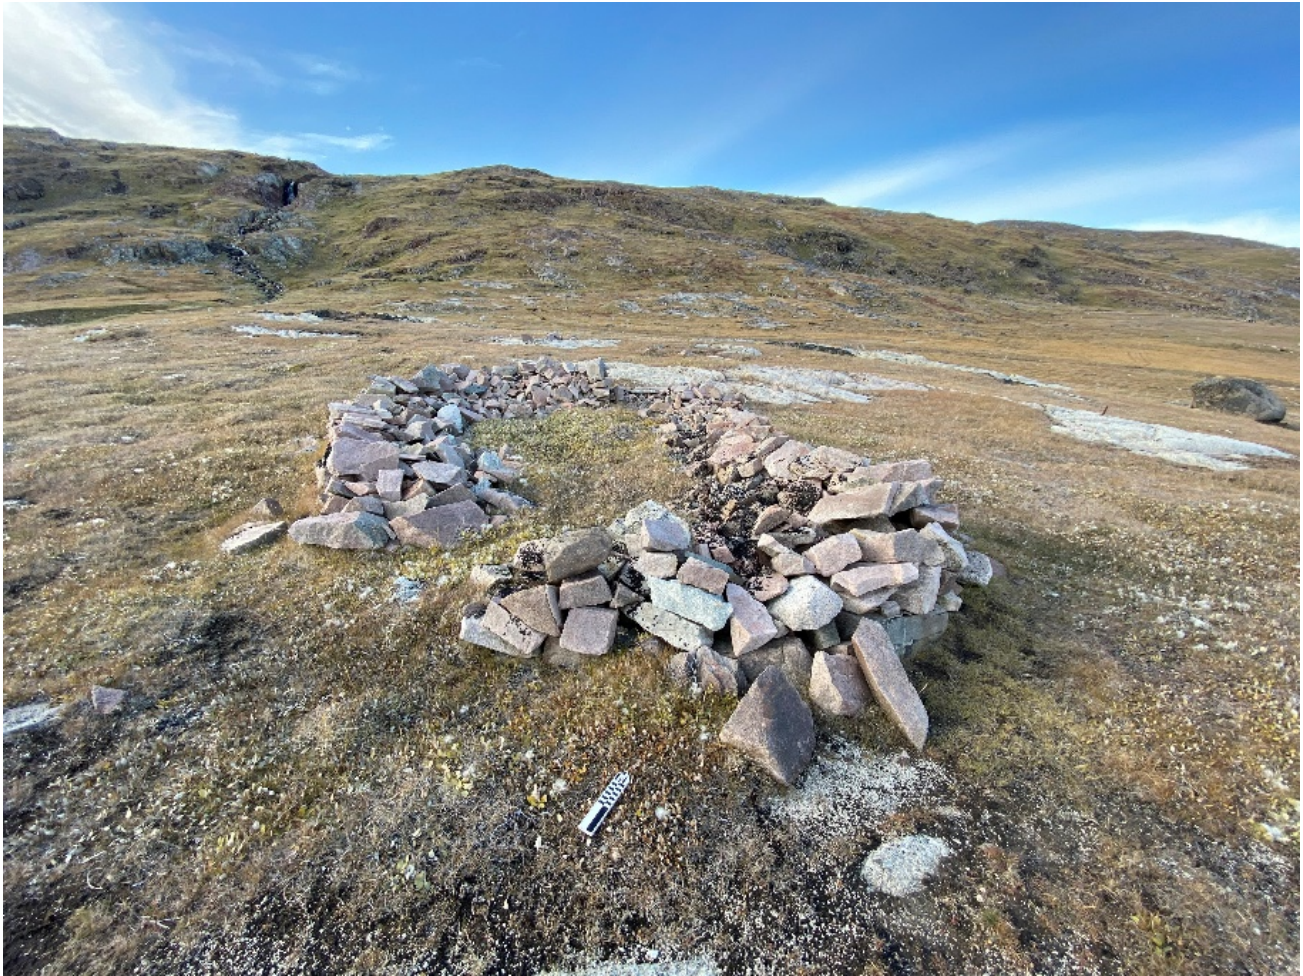
Fig. 66. Feature D003 at Artillery Point, facing northwest. Photo: Harmsen 2020.

Feature D003 (Fig. 66) is another possible ammo dump or a cache for artillery. The feature possesses a slightly distorted rectangular shape measuring approximately 6,8m x 5m, with a narrow entryway located at the southeast corner. In contrast to feature D002, the design is more open, and it is unclear if the piled stones in D003 also served as a buttress to a structure that has been removed (Fig. 67).

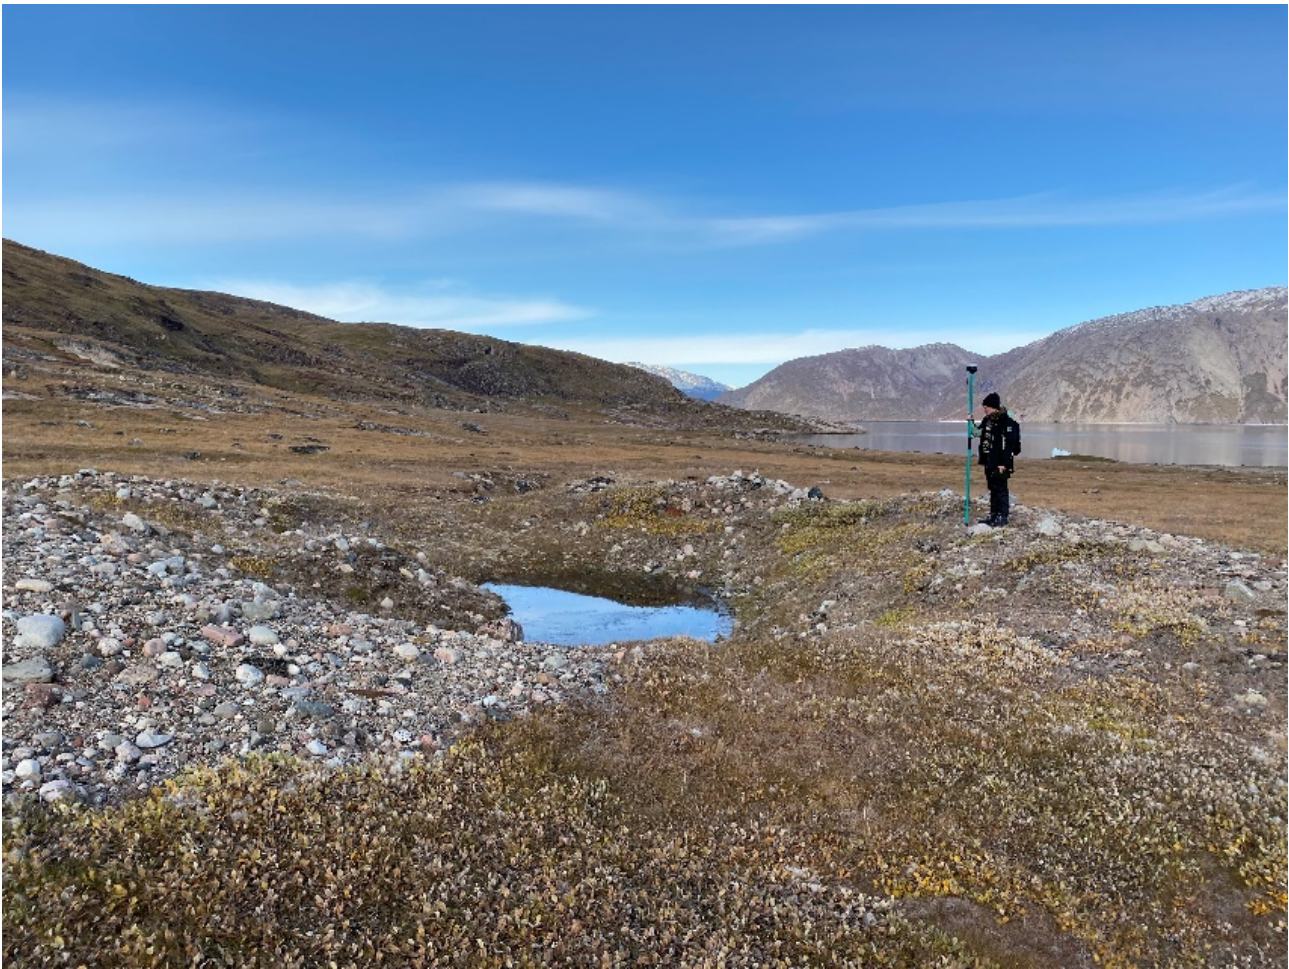
Fig. 68. Feature D004 at Artillery Point, facing north. Kristiansen shown in the photo for scale. Photo: Harmsen 2020.

Feature D004 (Fig. 68) exhibits a design that would have made it the likely location for one of the 155mm Long Tom guns (Guldager 2019:18). The feature is hexagonal and measures approximately 20m x 19m. The two crescent shaped earth and gravel ramparts that define D004's shape rise about 1-1.5 m above the surrounding terrain, flanked by openings on the northern and southern ends. The western rampart has been cut at a 30° angle from the northwest, with fill deposited in the center pit. At the time of the visit the center pit depression was filled with a shallow pool of standing water (Fig. 69).

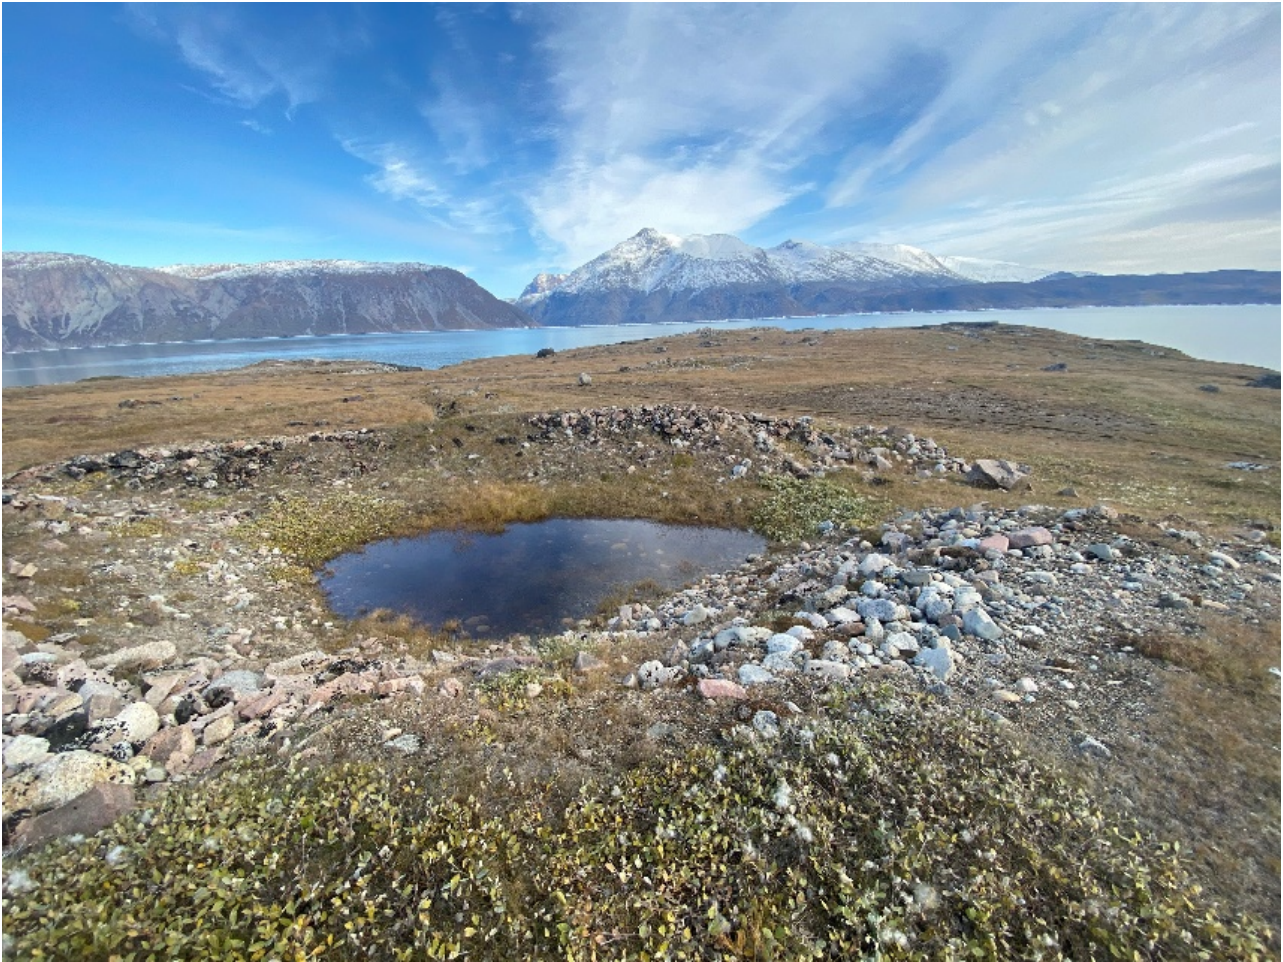
Fig. 70. Feature D005 at Artillery Point, facing west. Photo: Harmsen 2020.

Feature D005 (Fig. 70) is believed to be the second 155m Long Tom defense position at Artillery Point. The feature is more oval shaped, formed by two earth and gravel ramparts rising approximately 1-1.5 m above the surrounding terrain. D005 measures about 15m wide with a length of 19 m. Like D004, the feature has two entry ways at its northern and southern ends. The center depression of the feature was filled with a shallow pool of standing water at the time of the visit (Fig. 71).

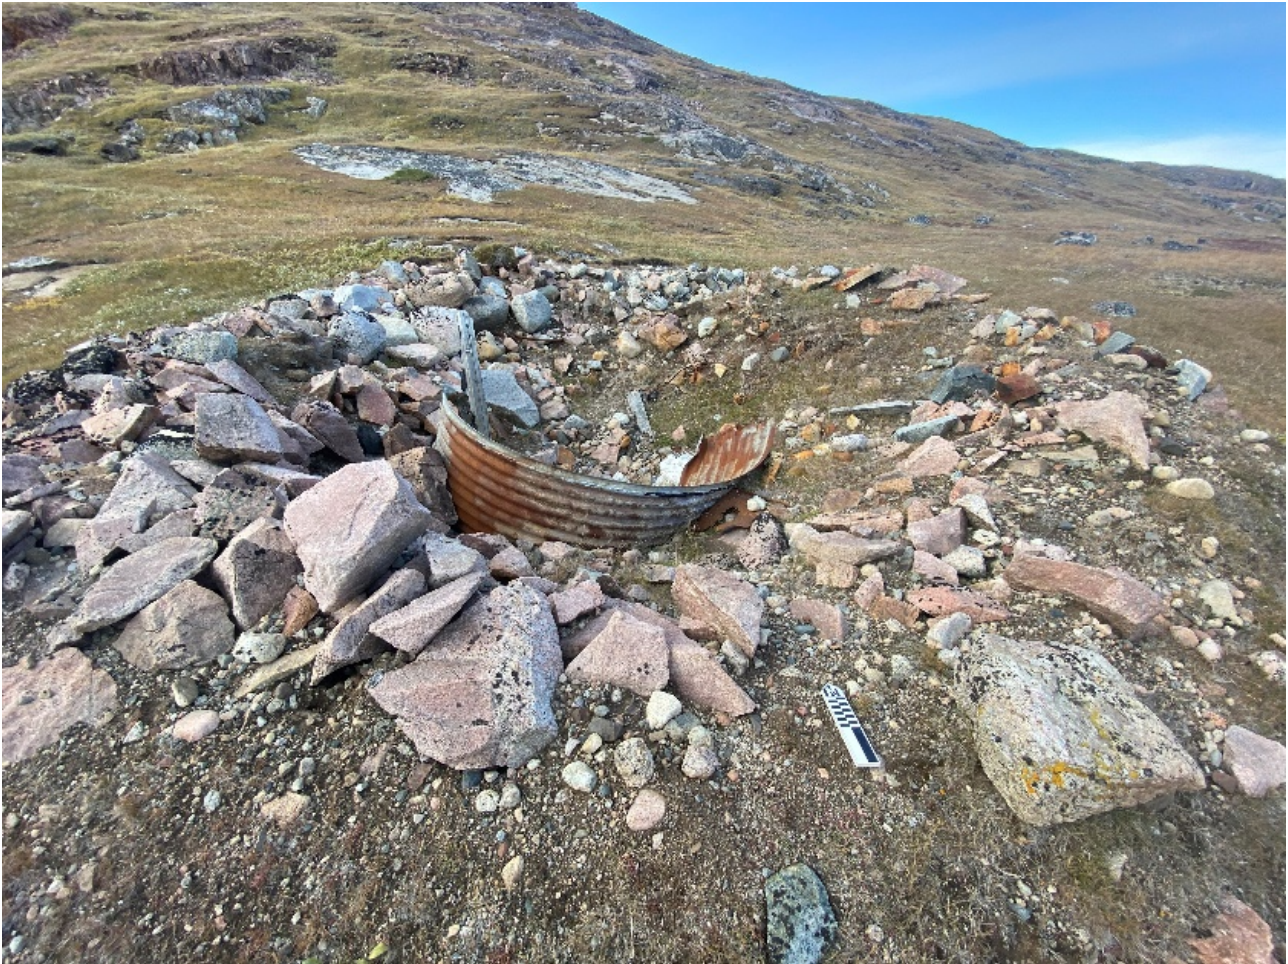
Fig. 72. Feature D006 at Artillery Point, facing north. Photo: Harmsen 2020.

D006 (Fig. 72) is an earth and cobble pit feature measuring approximately 11 m in length and 7 m at its widest point. The earthen walls of the pit rise roughly 1-1.5m above surrounding terrain. The specific function of this feature is unclear but could have served as a munition's depot or cache with an additional structure or built component resting inside the pit. A large fragment of a corrugated metal pipe and several pieces of wooden debris were present in the center depression of the feature (Fig. 73).

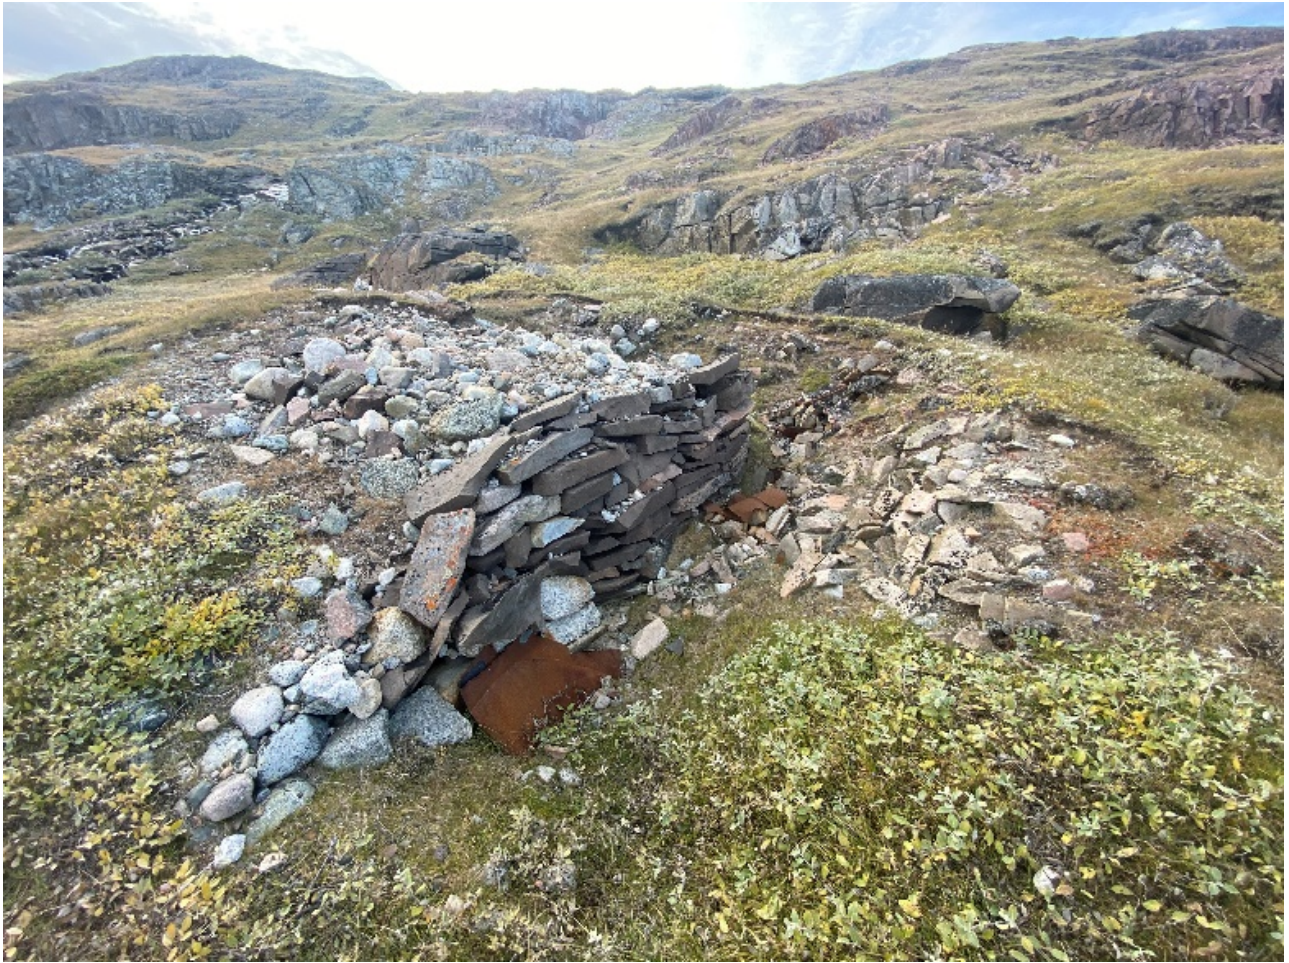
Fig. 74. Feature D007 at Artillery Point, facing southwest. Photo: Harmsen 2020.

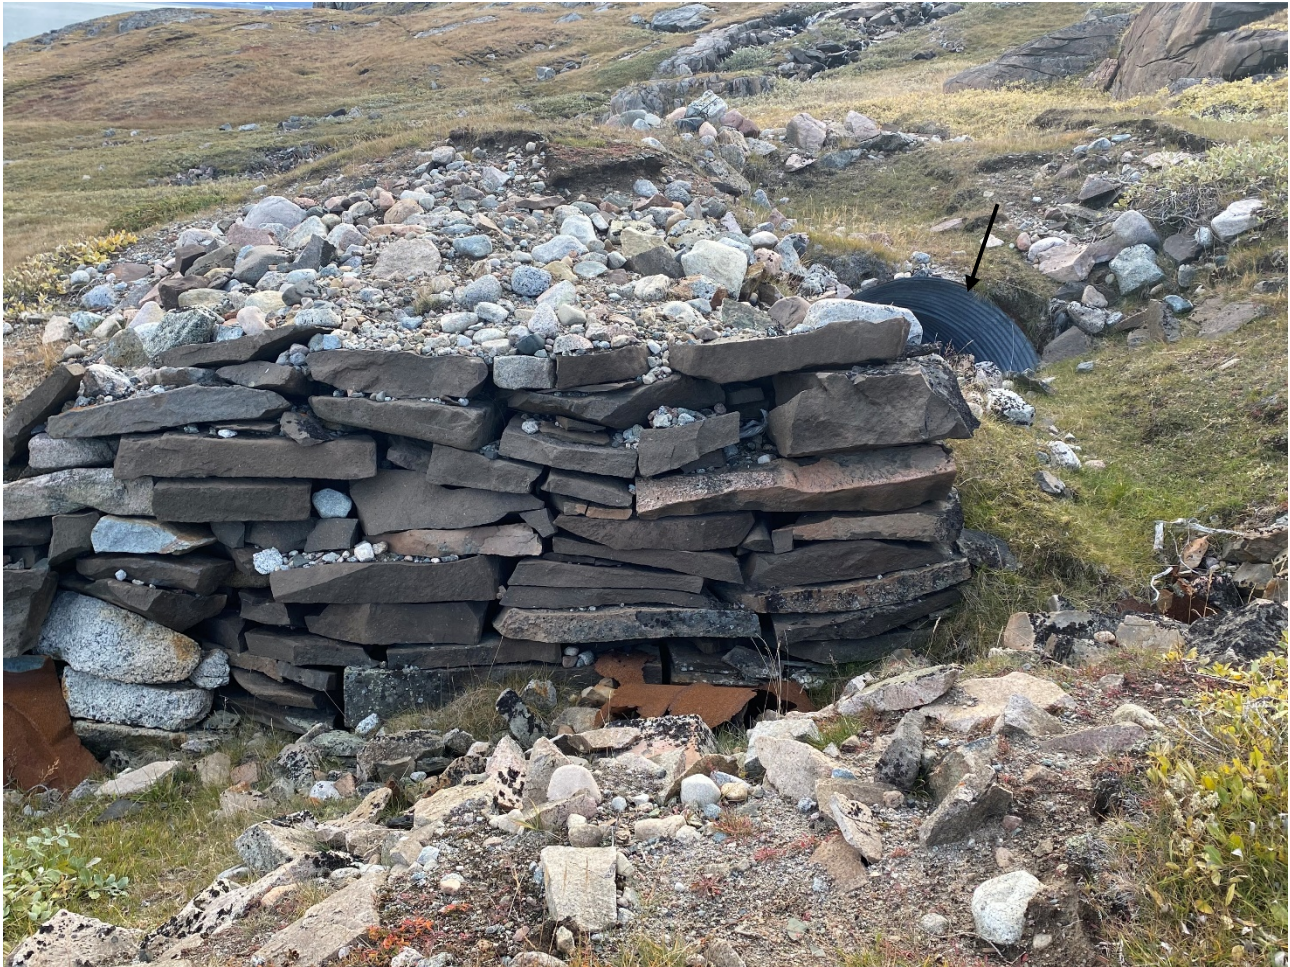
Fig. 76. The flagstone wall of D007, facing south. The arrow points to the entrance to the bunker on the right of the photo. A high concentration of wood and scrap metal and other loose building materials were observed around D007. Photo: Harmsen 2020.

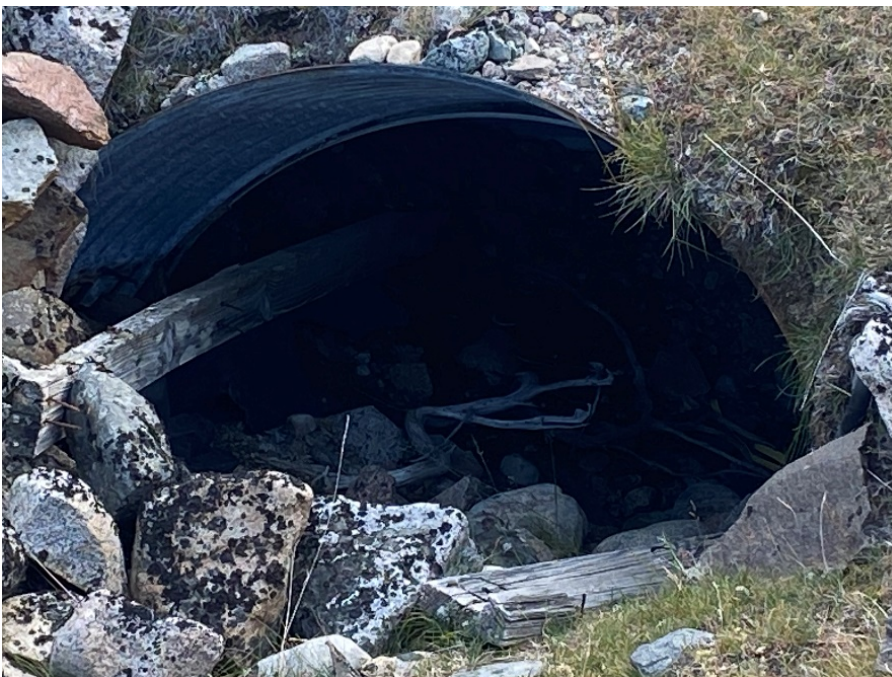
Fig. 77. Entrance to D007. The roof of the entrance was supported with a concave corrugated steel fitting. Several pieces of scrap wood and debris were present in the entrance. Photo: Harmsen 2020.

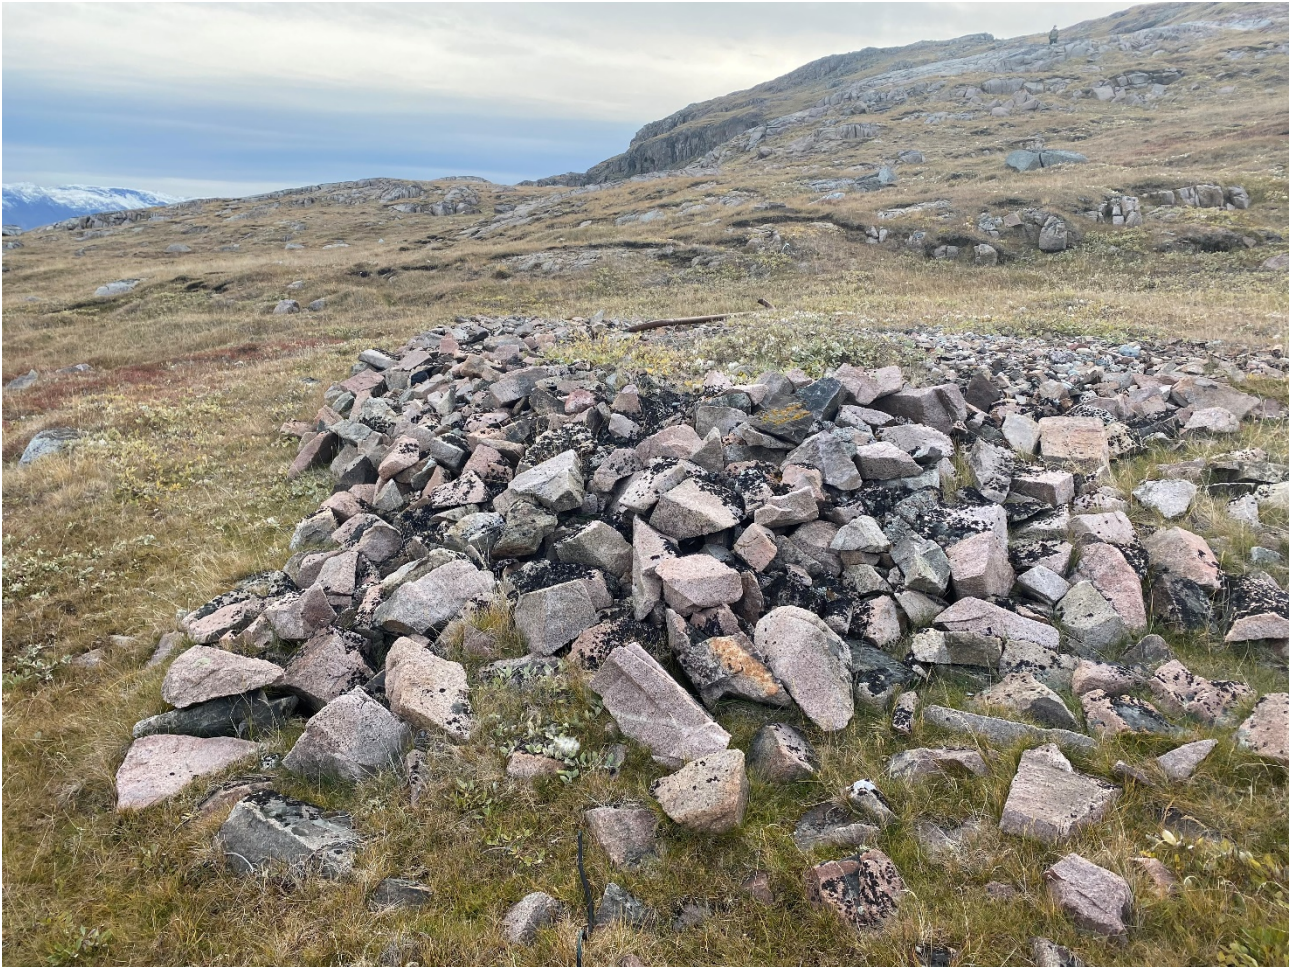
Fig. 83 Foundation F001, supposed location for electrical generator housing, facing south. Photo: Harmsen 2020.

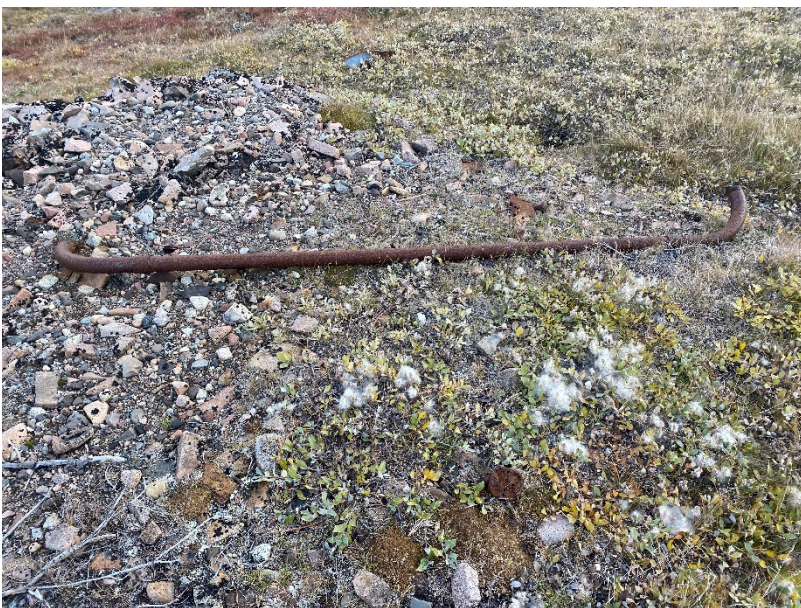
Fig. 84. Iron pipe observed on the surface of F001.

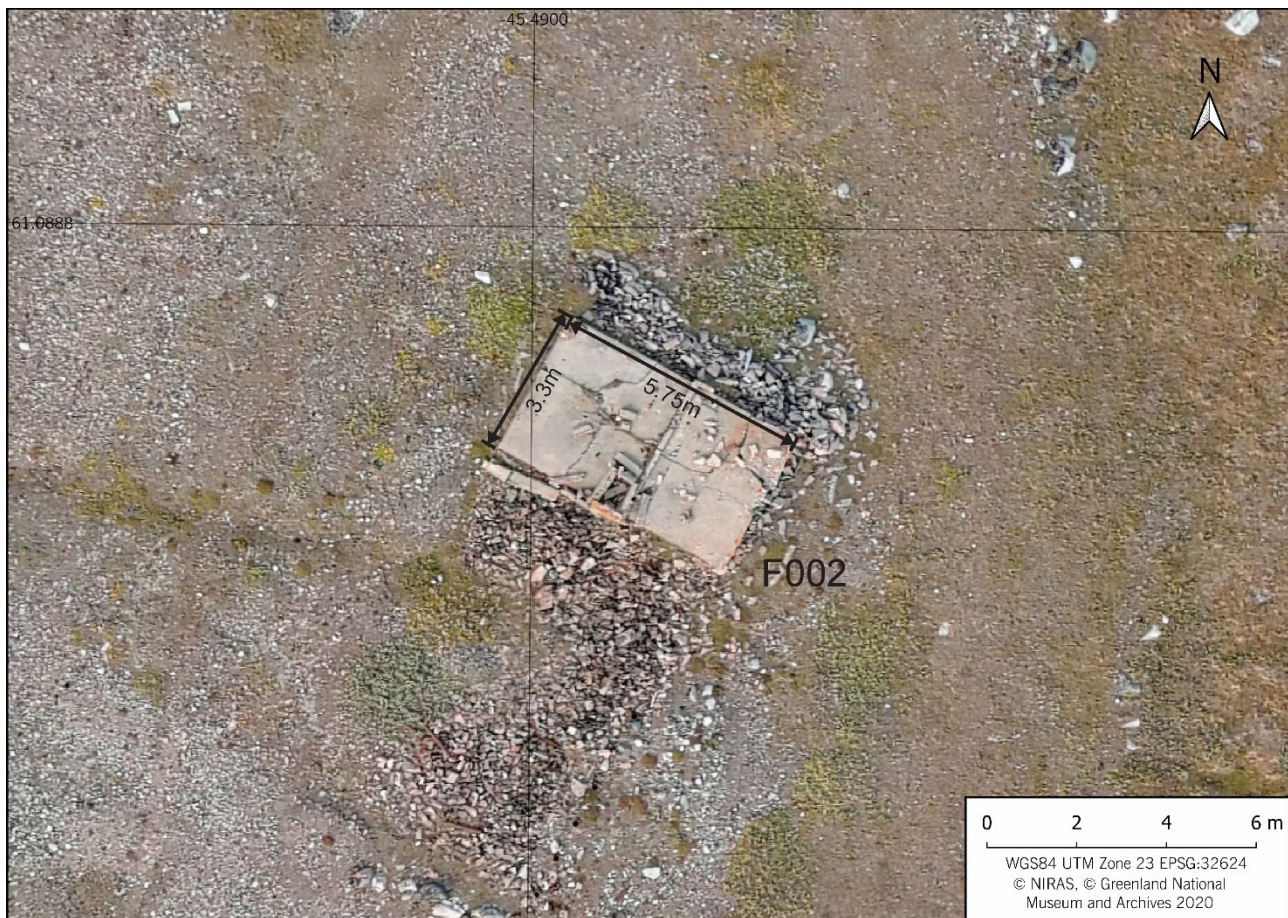
Fig. 85. Ariel view of feature F002, cement foundation observed at Artillery Point. Old pipes and the dense pile of broken cobbles found around the foundation used suggests the building may have extended over a larger surface area in the past. Photo: NIRAS, 2020.

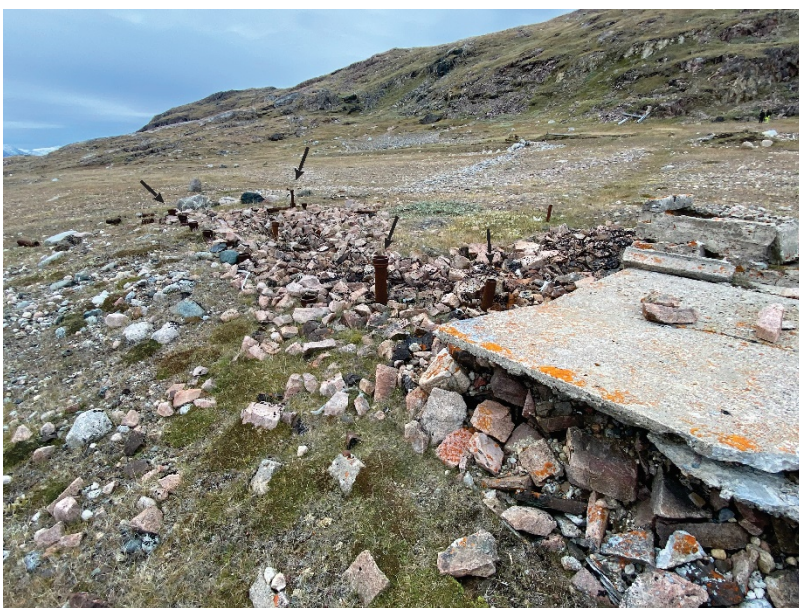
Fig. 87. Several infrastructure elements such as exposed plumbing and pipe fixtures are found in connection with F002. Arrows point to exposed pipes. Photo: Harmsen 2020, facing southwest.

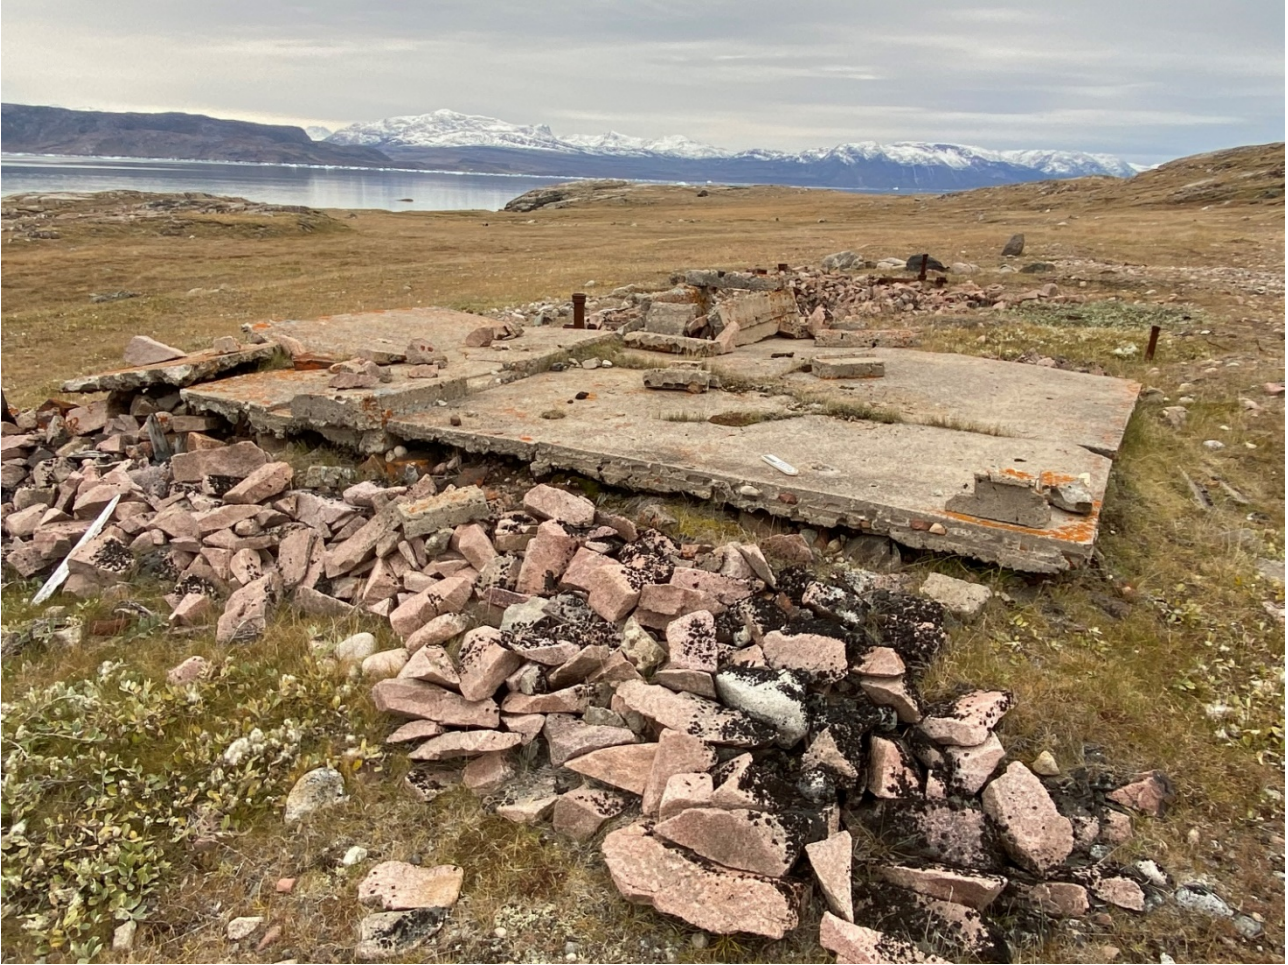
Fig. 88. F002 at Artillery Point. The cement platform is in extremely poor condition, with visible breakage and cracking due to exposure to the wind, rain and ice over the last 70+ years. Photo: Harmsen 2020, facing south.

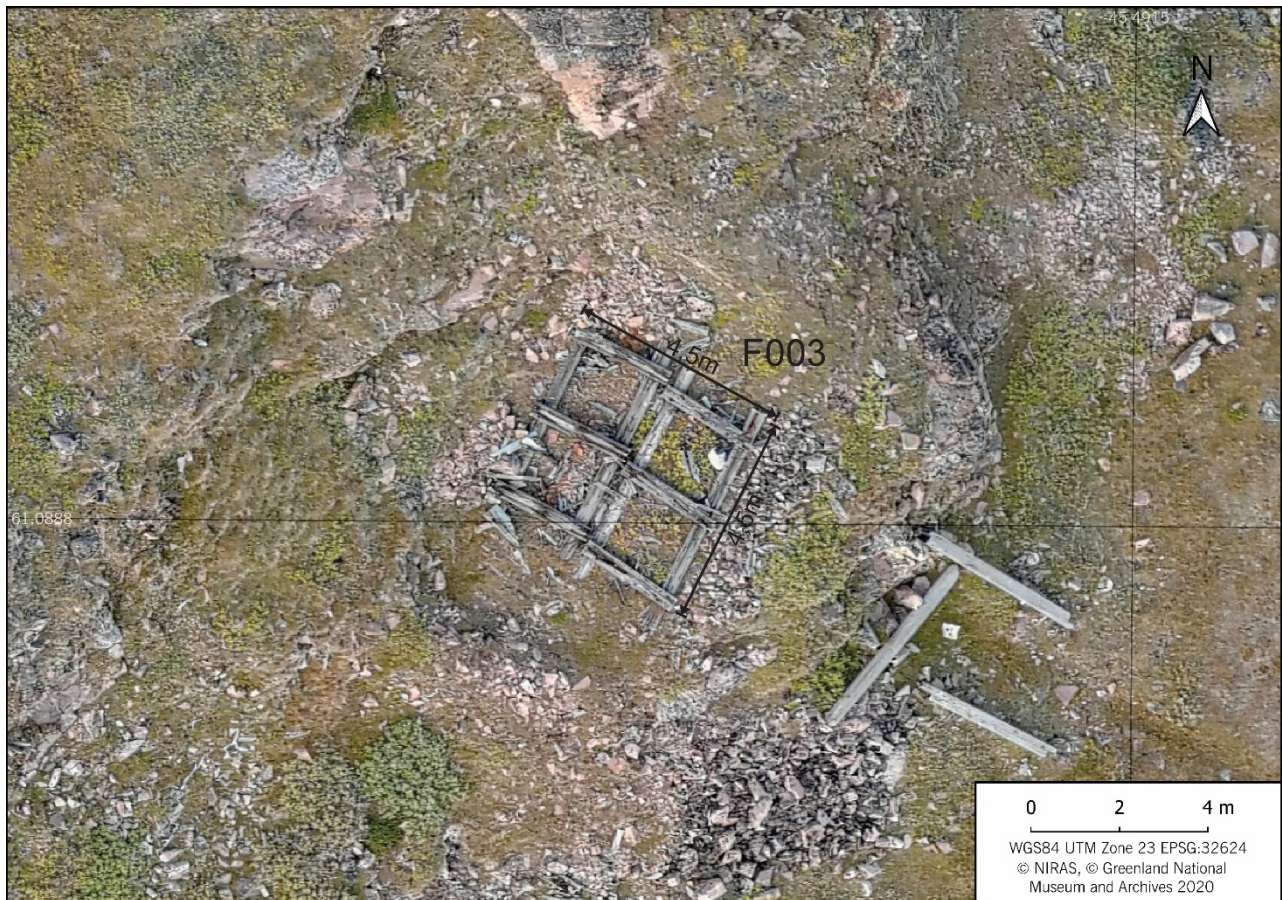
Fig. 89. Areal view of foundation remains of F003 at Artillery Point. Three large timbers are seen lying below the natural cliff shelf to the southeast.

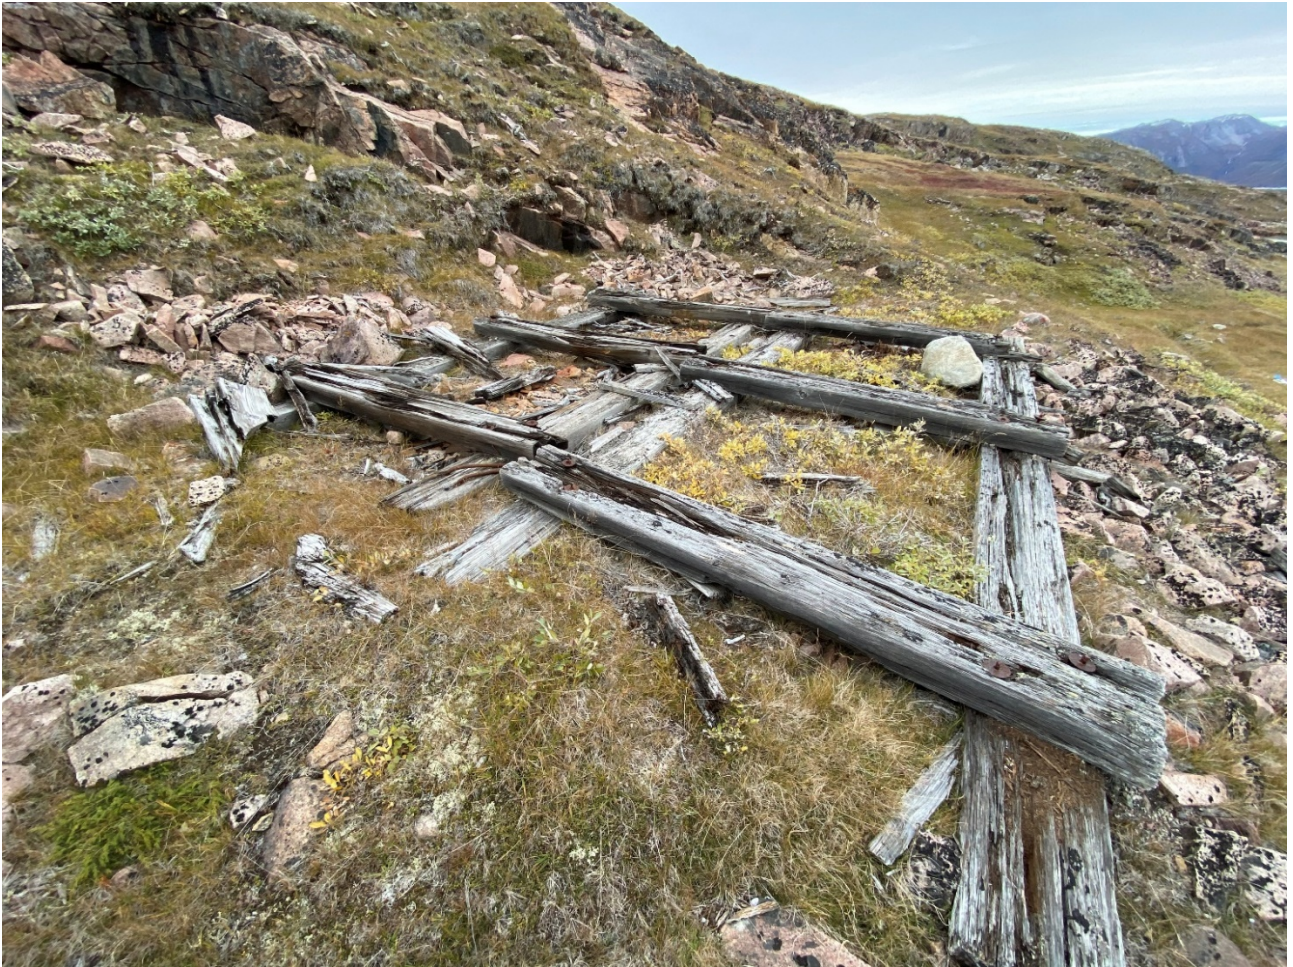
F003 is a 4,5m x 4,5m heavy timber platform frame perched on a natural shelf overlooking the camp (Fig. 89). Several timbers lie below the cliff, appearing to have been moved or fallen at an earlier point. As in seen in other parts of the camp, a broken cobble base was used to level and secure the original structure (Fig. 90). The function of this building remains unknown.

Fig. 90. Foundation F003 at Artillery Point, facing to the north. Photo: Harmsen, 2020.

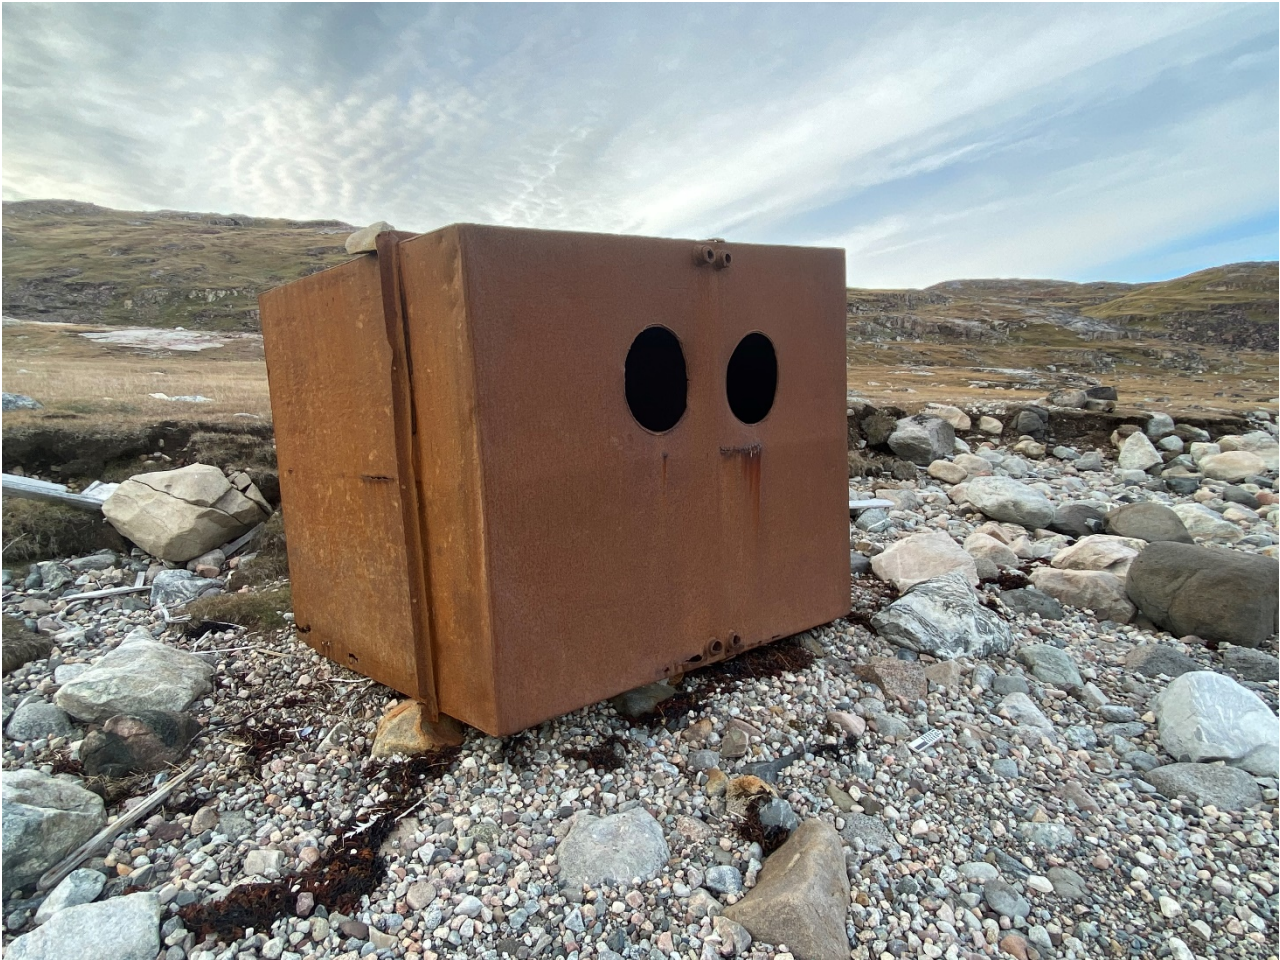
Fig. 94. The steel metal container located on the beach at Artillery Point.

Both large and small artifacts, demonstrative of the American period, were identified on the surface at Artillery Point and documented in more detail in Appendix B. However, it is worth mentioning that there is one large historic element in the form of an enormous steel container (Fig. 94) found on the beach at Artillery Point that is both unique and a prominent part of the landscape. The container, located at 61.08843 N°, -45.48787 E° measures 1,8 m x 2,7 m and approximately 2 m in height. The exact function of the container is unclear but may have served as a water tank or reservoir for the camp (see Henriksen, Storm Boe, and Kann Hostrup 2021a).
