ARCHAEOLOGICAL SURVEY OF BLUIE WEST 3, GAMATRON, ARTILLERY POINT AND CAMP CORBETT, KUJALLEQ KOMMUNE, SOUTH GREENLAND, 18-25 SEPTEMBER 2020

Report prepared by:

May 2021, Nuuk

Nunatta Katersugaasivia Allagaateqarfialu // Greenland National Museum and Archives

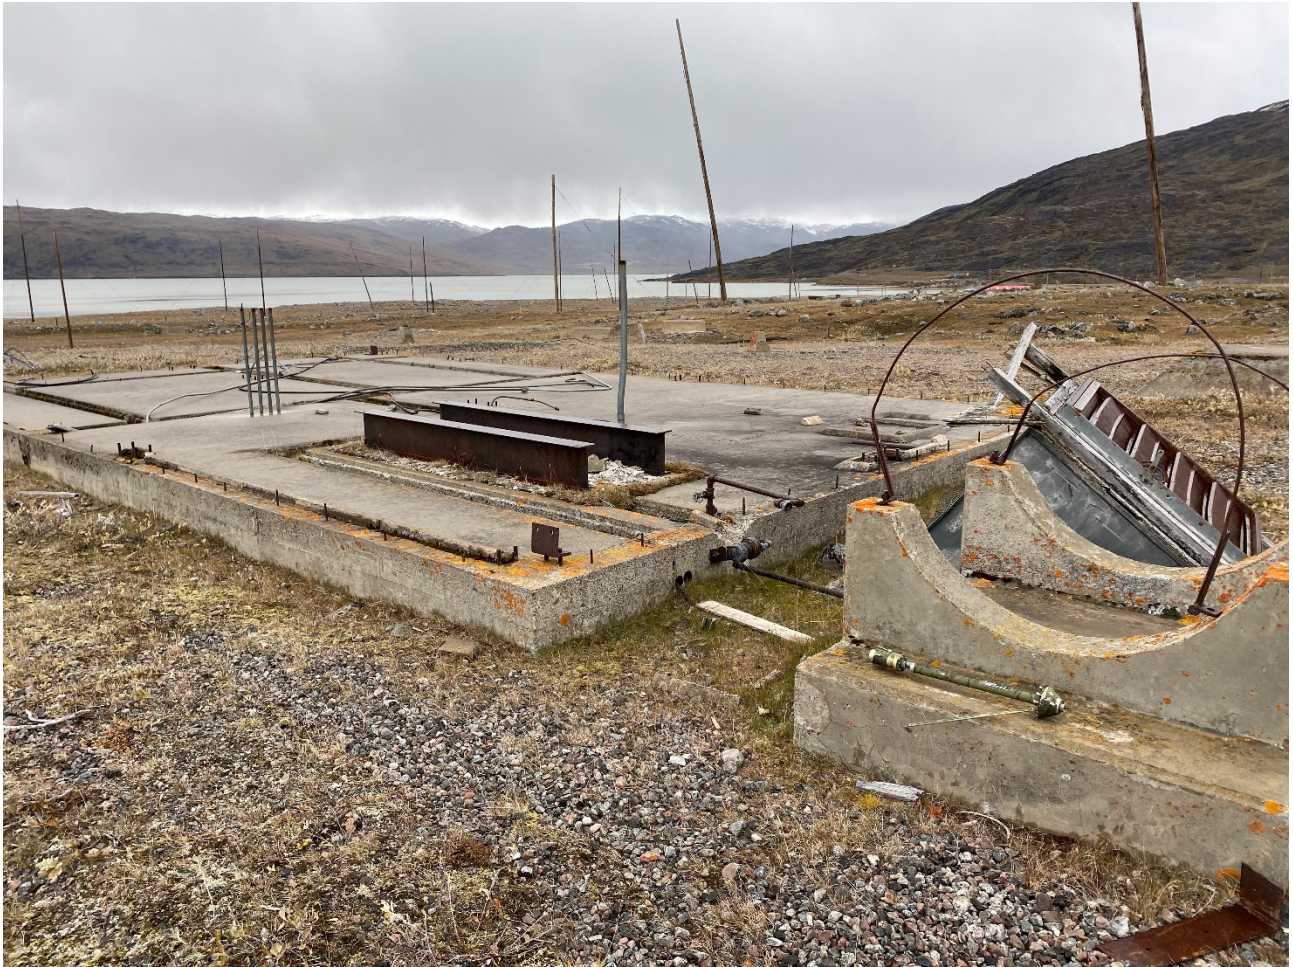
Overall, numerous elements observed on the ground during the survey were directly attributable to the American period. The most ubiquitous features identified were the many and wooden antenna masts, many of which are still standing (Fig. 97), although several have either been intentionally cut down or burned by Paviasen's family in the 1980s. The station's main 185 m steel antenna mast was also still present on the ground at Kiattut and described in further detail in section 2.4.3. At least nine ($n=9$) buildings are known to have been present ca. 1958, that included housing for communications transmitters, generators and helix coil housing (Fig. 98), however there were probably several other buildings that would have included living quarters and a camp mess hall. Two dumps are also found to the northeast with several elements found on the surface indicative of the camp's operation as a communication and radio beacon. Several surface objects connected to the American period were collected during the survey that provide insight into the era of the camp's operation and day-to-day life, described in more detail in Appendix B. A cable car was also known to have served as

Fig. 97 .The 'mast forest', remnants of Camp Corbett's antenna array, seen in the background behind a cement foundation of building S-820, communications transmitter housing (see Fig. 108, feature nr. F017), facing northwest. Photo: Harmsen 2020.

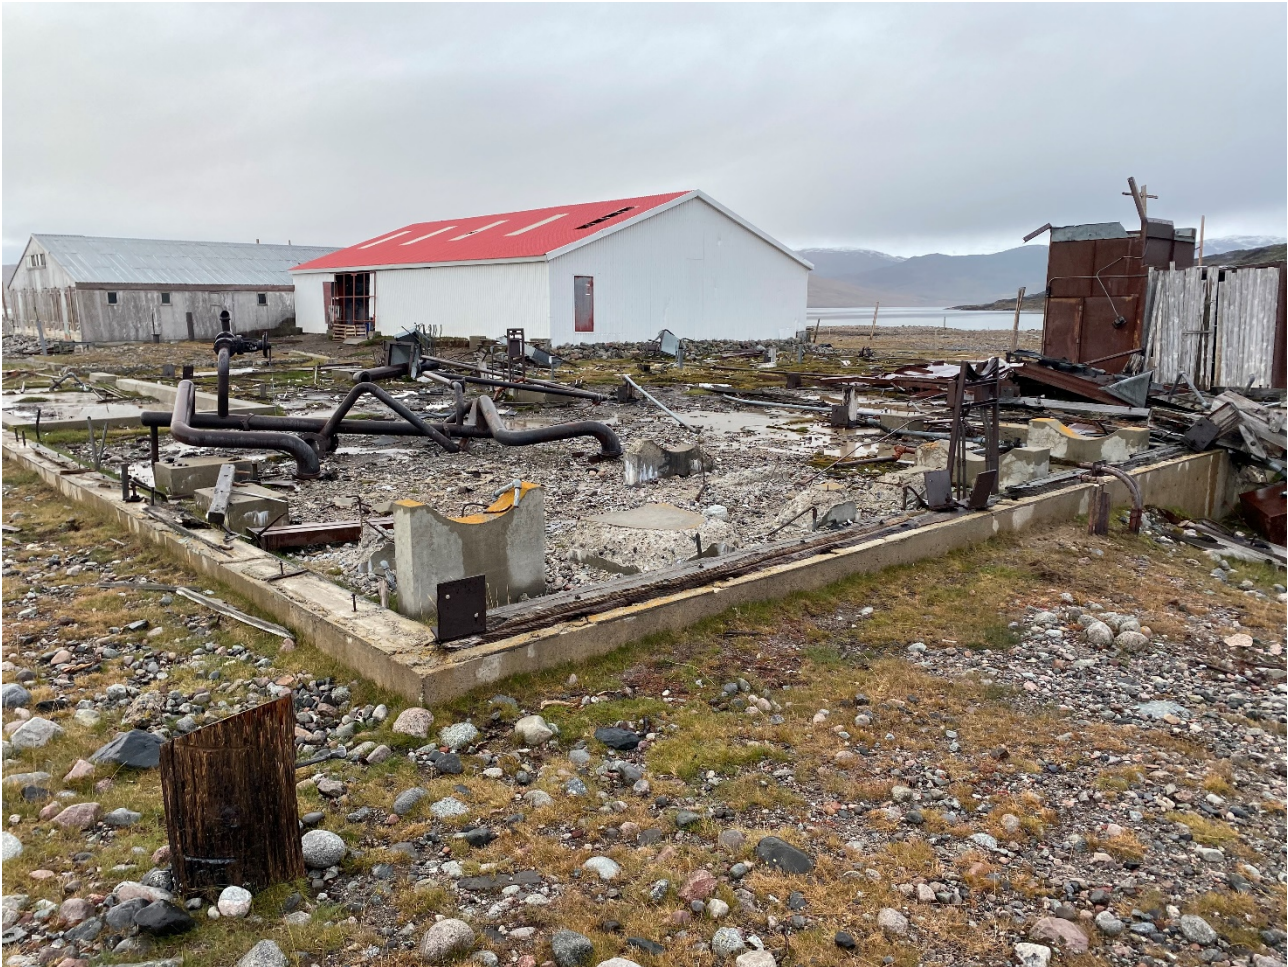
Fig. 99. Two standing buildings are seen in the photo: on the left, B005, sheep stable owned by local farmer, farmer Eskild Paviasen. To the right can be seen the small storage lying on the foundation of S-817 (see Fig. 107., feature nr. F012) shed built from scrap and recycled materials left over from the American period. Both are constructed on the foundations of former American buildings but are of modern construction and possess no historic value.

A total of seven ($n=7$) standing buildings were identified at Camp Corbett, all of recent construction with the two exceptions of B003 and B004, which appears to be S-813 and S-815 respectively (see Fig. 99). Building B-004, a large sheep stable and barn structure, is and formed of two adjoining buildings built on the foundation of S-816 (Fig. 99). Except for B003 and B004, all other buildings observed at Camp Corbett were constructed after 1958 and have no particular historic value.

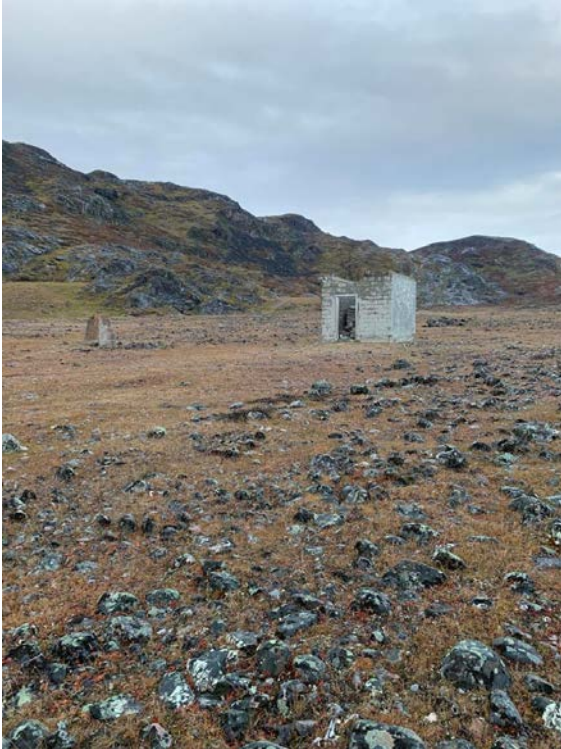
Fig. 103. Building B003, facing north. Photo: Kristensen 2020.

B003 and B004 are (Fig. 102–Fig. 104) the only historically identifiable standing buildings found at Camp Corbett. Both buildings served as housing for the stations helix coils that were part of the radio transmitter. Both buildings are of similar construction and measuring 15 m² and built from 8"x16" concrete cinder blocks, with wood framing for the doors and small window apertures. B004 still possessed its original wooden roof, while B003's roof was no longer present. Both structures are not currently in use. B004 used as storage for several tons of sacks filled with concrete mix. The sacks exposure to the elements have now made them no longer viable and they have solidified, essentially making the concrete now a permanent part of the buildings. B003 is missing its original roof and appears to be only used for storage of miscellaneous materials by the local farmer.

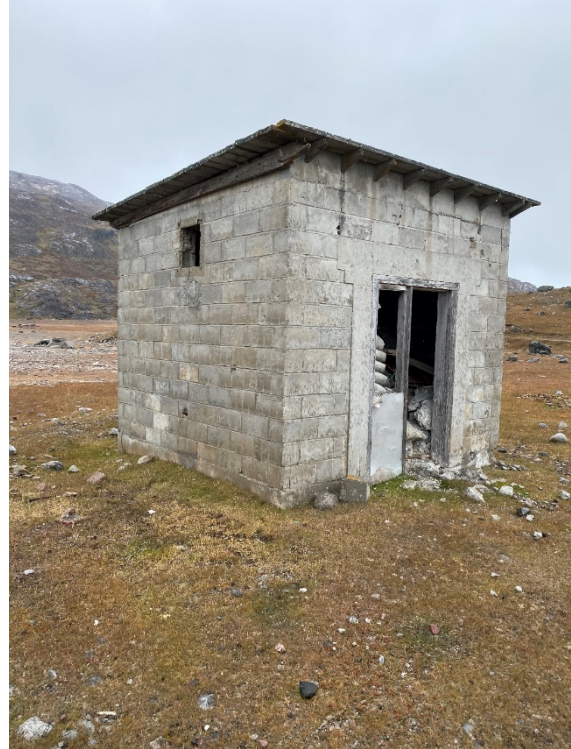
Fig. 102. Building B004, facing northwest. Harmsen 2020

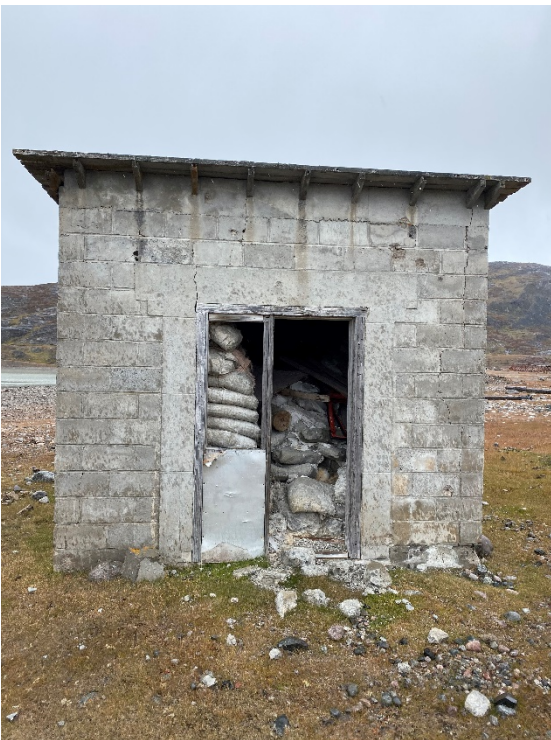
Fig. 104. Building B004, showing concrete mix sacks that have solidified and now become a permanent part of the structure. Photo: Harmsen 2020.

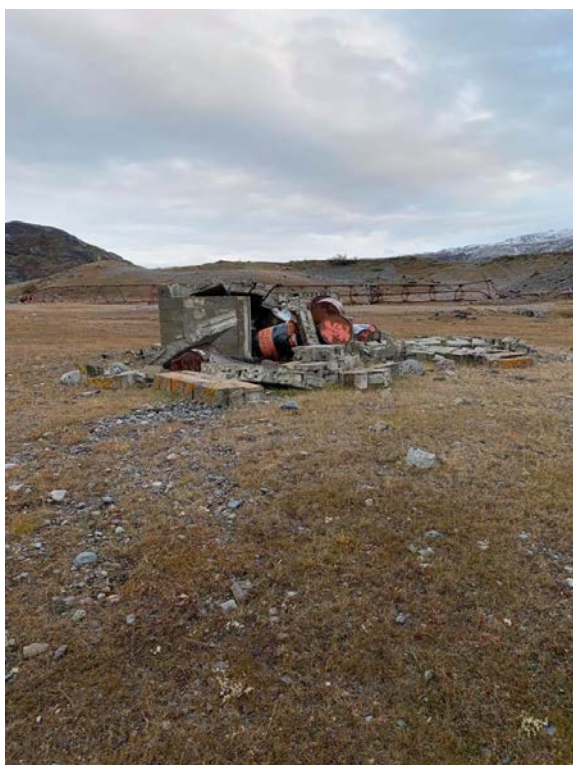
Fig. 106. Feature F006, formerly S-818, helix coil housing. Photo: Kristensen 2020.

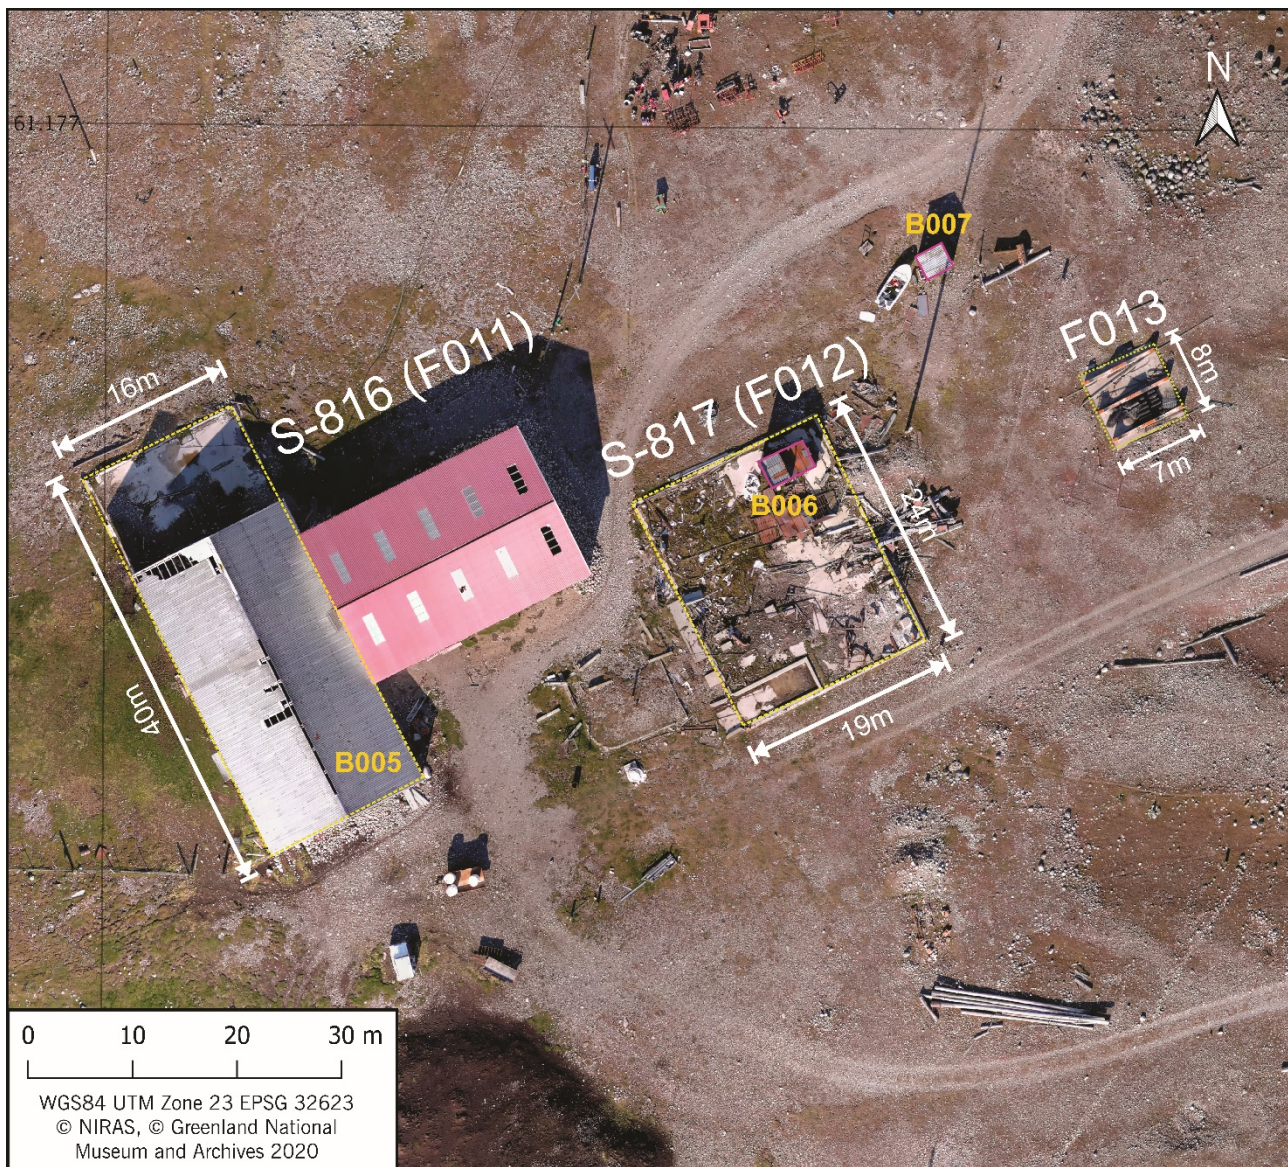
Fig. 108. Aerial view of the Paviasen sheep stables (B005) built on the footprint of S-816 (feature nr. F011), the perpendicular annex building with the red roof is a more recent extension of the building. A small makeshift shed (B006) was constructed in the northeast corner of the power plant building, S-817 (feature nr. F012) from scrap metal and other building materials left behind by the Americans.

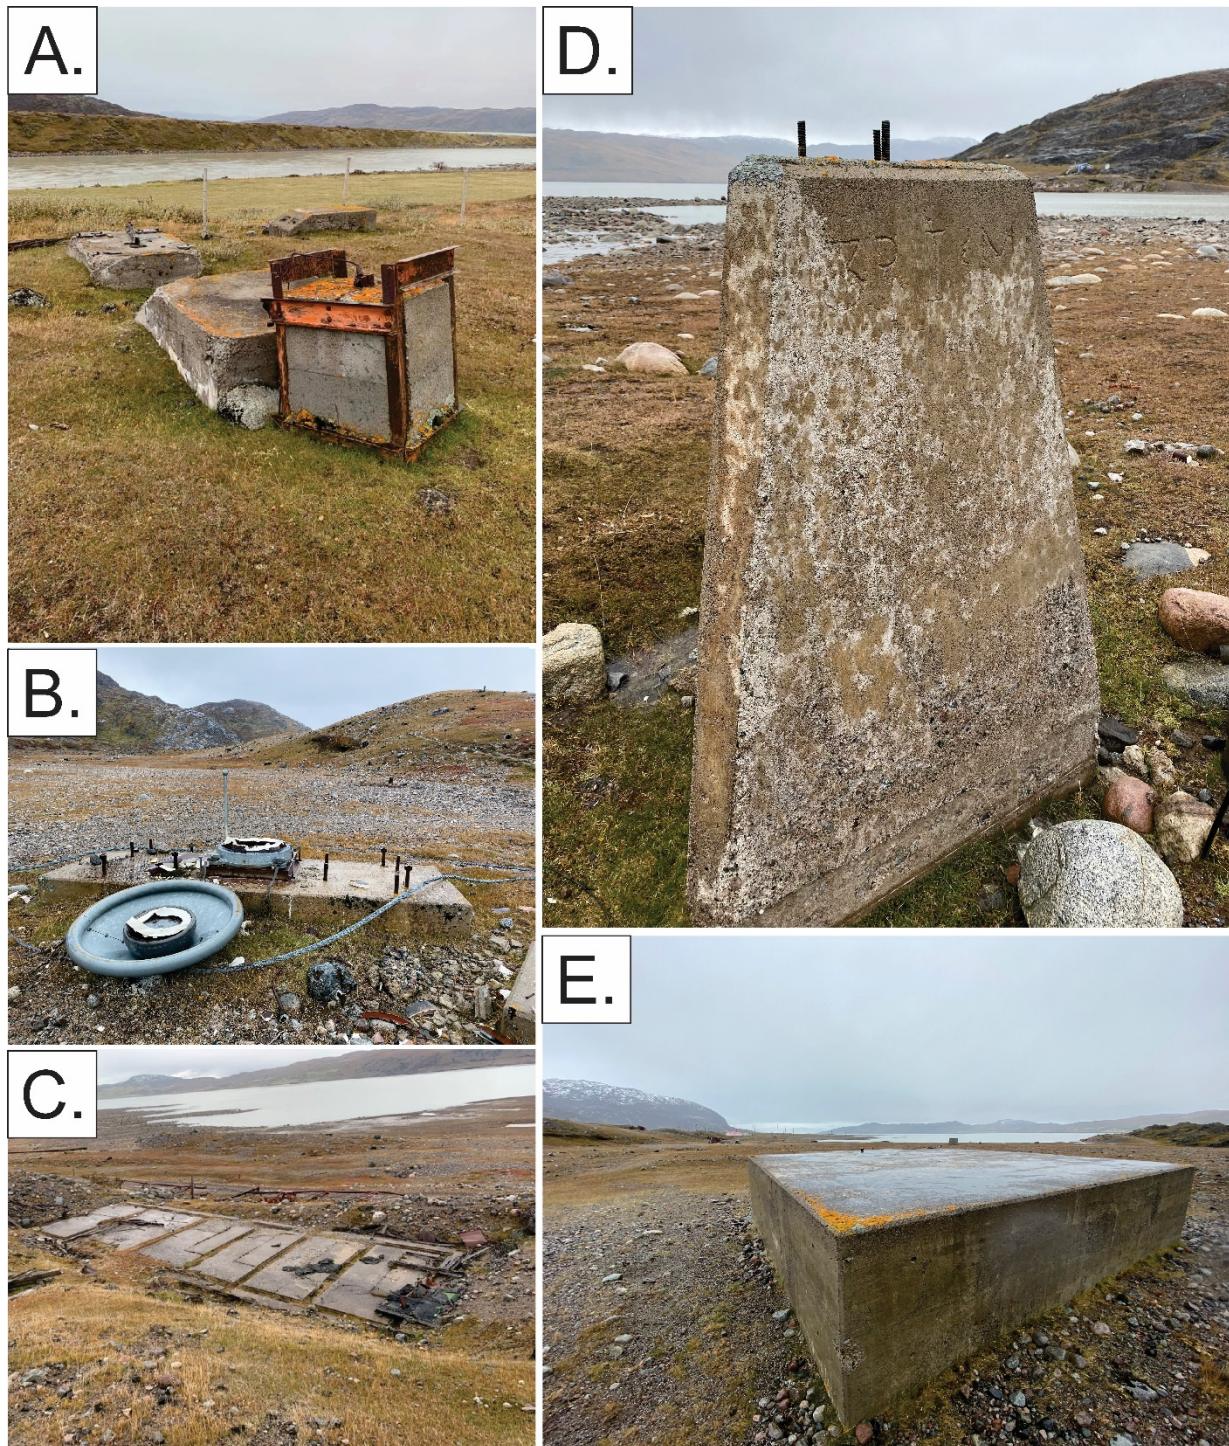
Fig. 109. A variety of different types of concrete and cement elements and foundations were identified at Camp Corbett. (A.) F022a, broken cement foundation remains with steel bracing facing south; (B.) F005f, part of the foundation for the steel mast, two ceramic insulators and tension steel cable line was still present at the site, facing northeast; (C.) F009, possibly the footprint of the emergency power generator, facing west; (D.) F002, precast concrete pylon with inscription “3^D I & M,” facing north; (E.) poured concrete platform (F001) that anchored the steel mast antenna, facing south. Photos: Harmsen and Kristensen 2020.

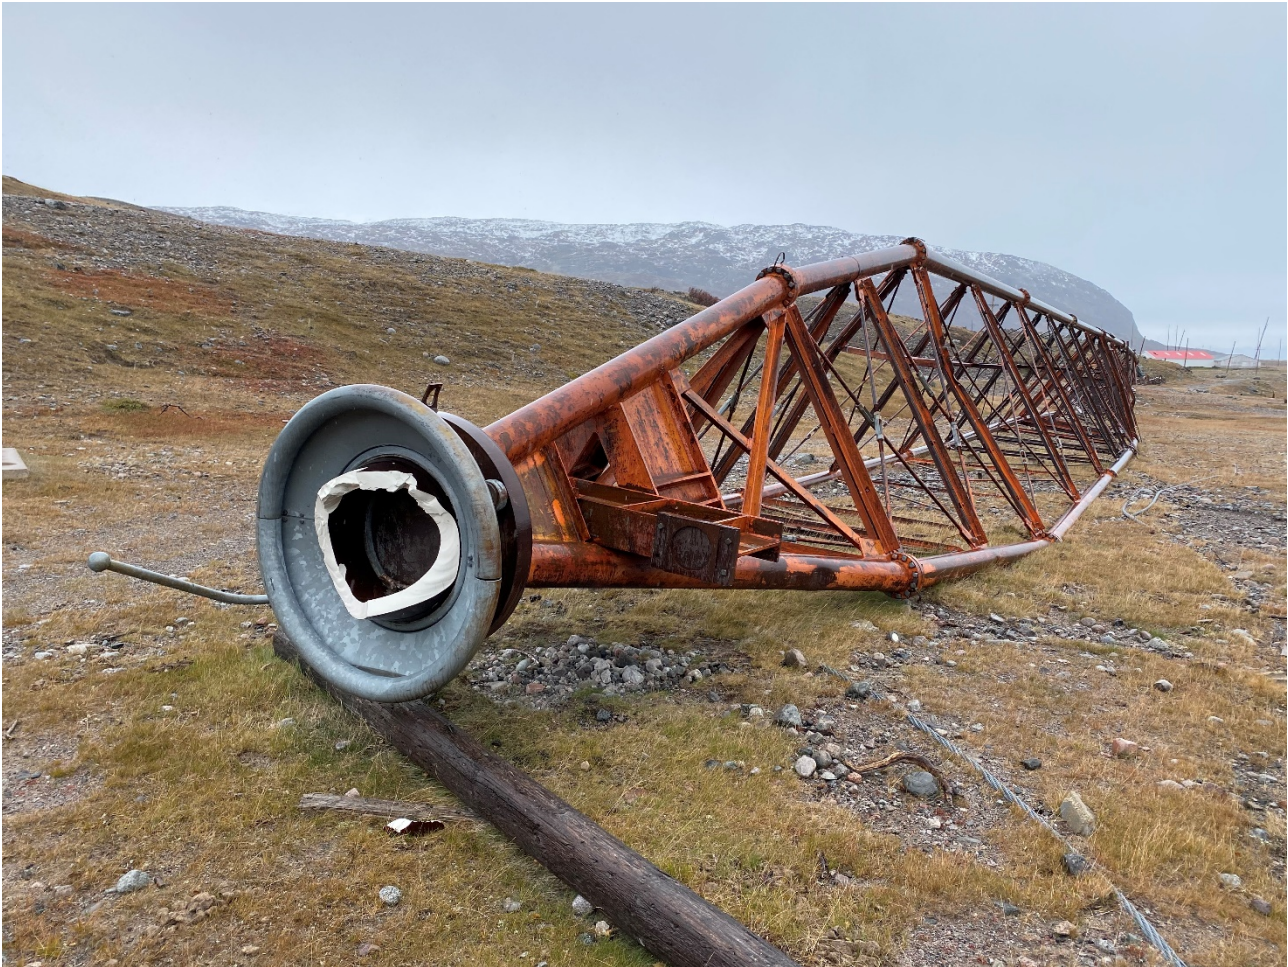
Fig. 111. The steel monopole antenna mast at Camp Corbett originally stood at a height of 185 m above the ground. The mast have been left in place along with remnants of its various components. Photo: Harmsen 2020.

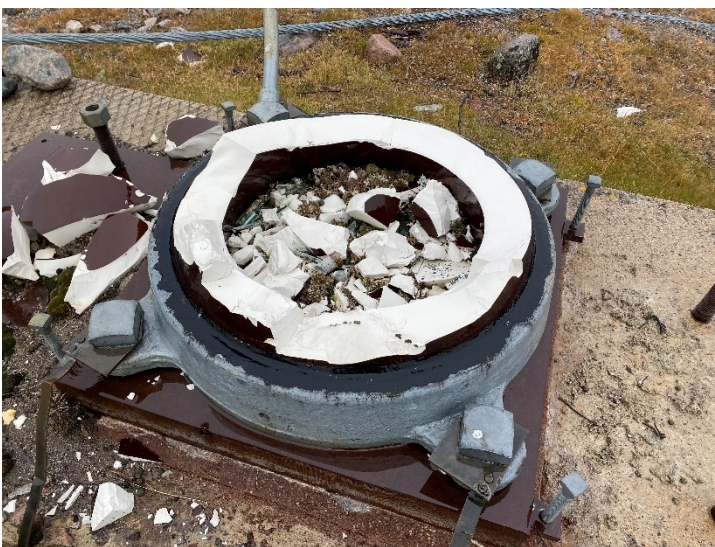
Fig. 112. Ceramic insulator base of the steel antenna mast. Photo: Harmsen 2020.

Originally measuring ca. 185 m high, the remains of the steel monopole antenna mast was by far the most dominant visible remnant of Camp Corbett's operation (Fig. 111). When the camp closed, the mast was pulled down and left in situ along with its various components, i.e., ceramic insulators (Fig. 112), steel cables, wood, the cement base, and several cement anchors (F001, F004, F012). Local farmer, Eskild Paviassen, reported the collection of approximately 3.5 tons of copper wire from the antenna mast. Further detail on the technical explanation of the steel mast is provided in Storm Boe, Kann Hostrup, and Henriksen (2021: 20-21).

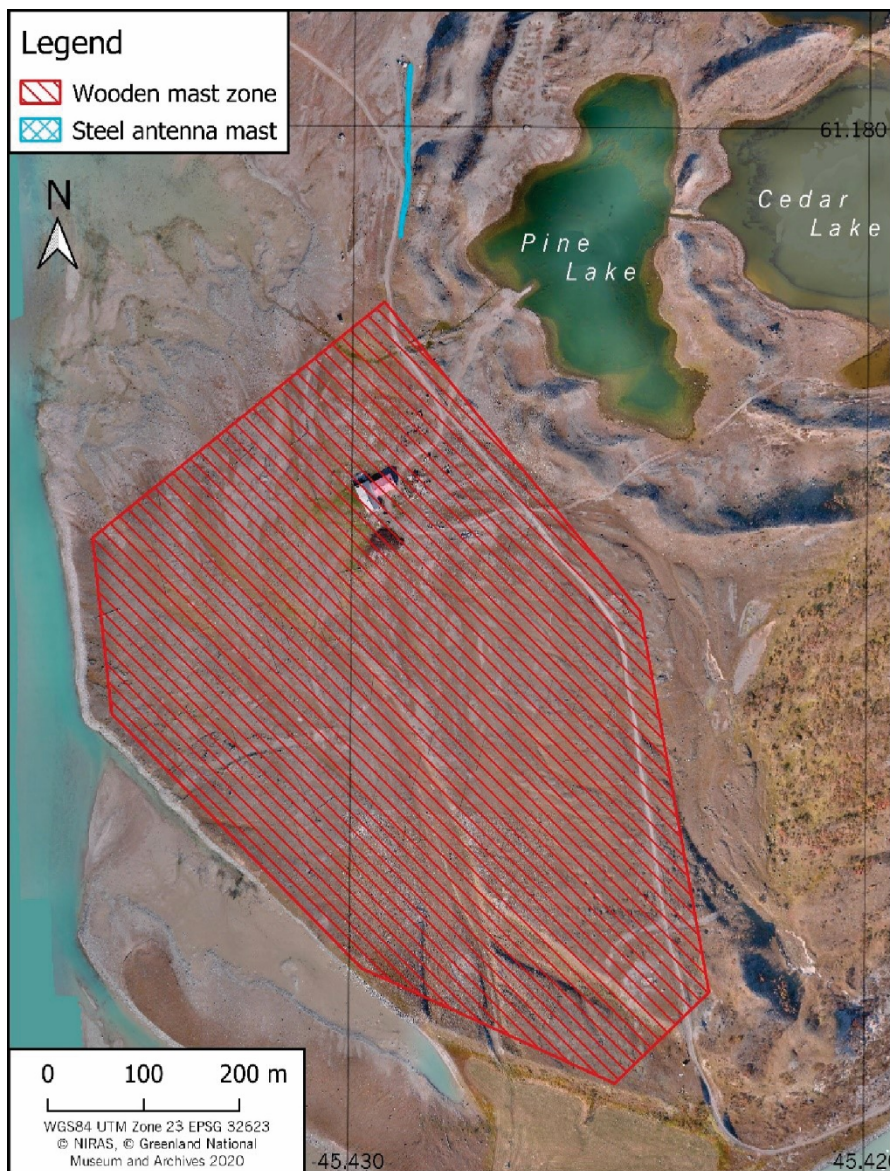
Fig. 113. The wooden mast zone at Camp Corbett covered an area of approximately 31 ha. During the station's operation over 50 wooden masts would have comprised the high-frequency antenna array. The remains of the 185 m steel mast antenna lies directly north of the wooden mast zone.

The wooden mast zone, or “mast forest” (Fig. 113) covered an approximate area of 31 ha. Several of the wooden antenna masts are still standing. During the camps operations, the zone contained over fifty masts that formed the station's high-frequency antenna array (Fig. 114). At the time of inspection many masts were observed on the ground. The terrain of this area heavily disturbed with different types of metal and wood debris and evidence of massive earth movement by heavy equipment and road grading (Fig. 115).

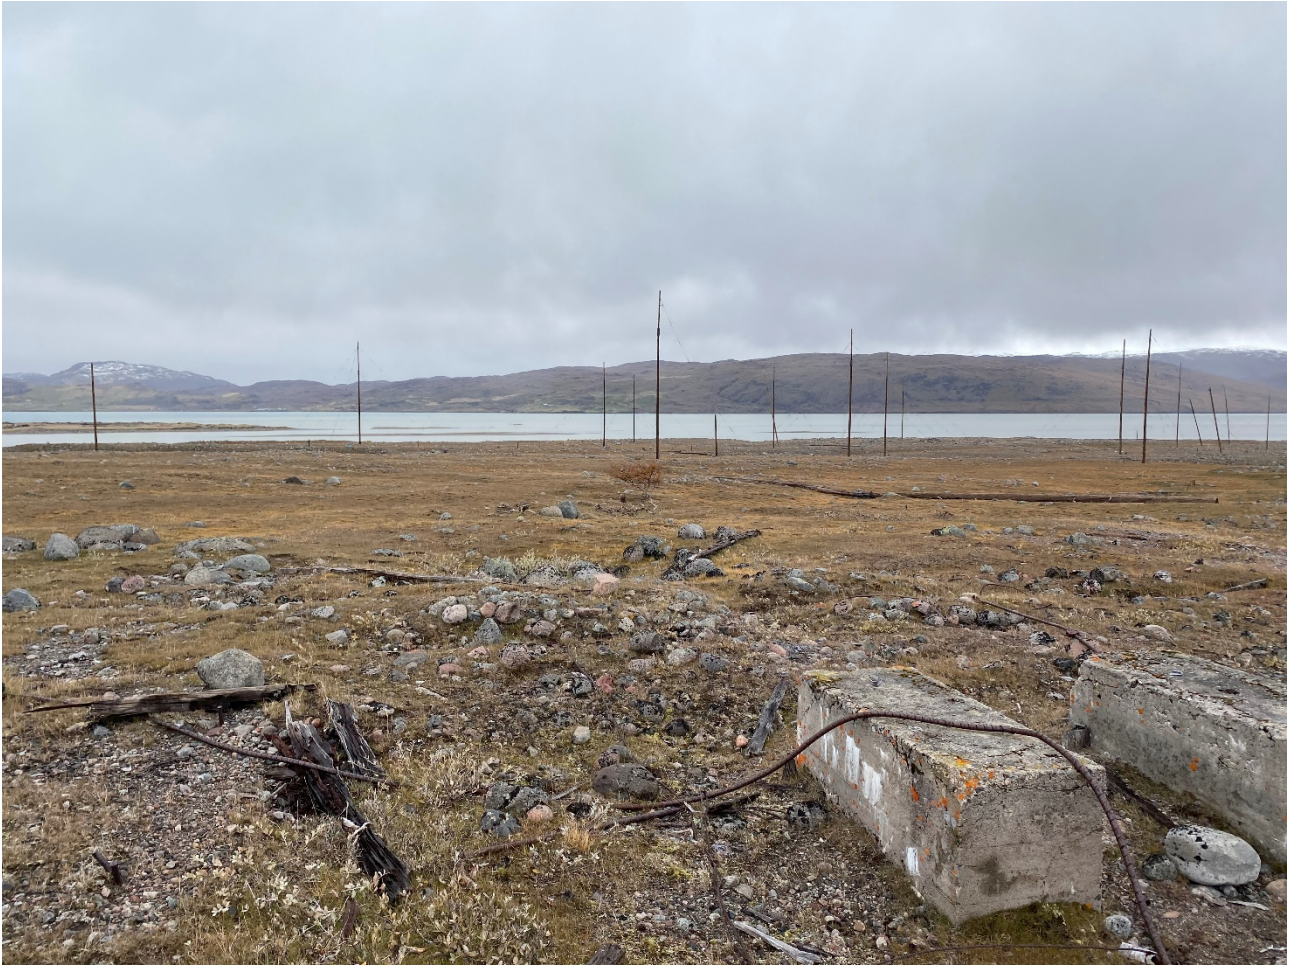
Fig. 115. Inside the wooden mast zone, facing south from F015. Photo: Harmsen 2020.

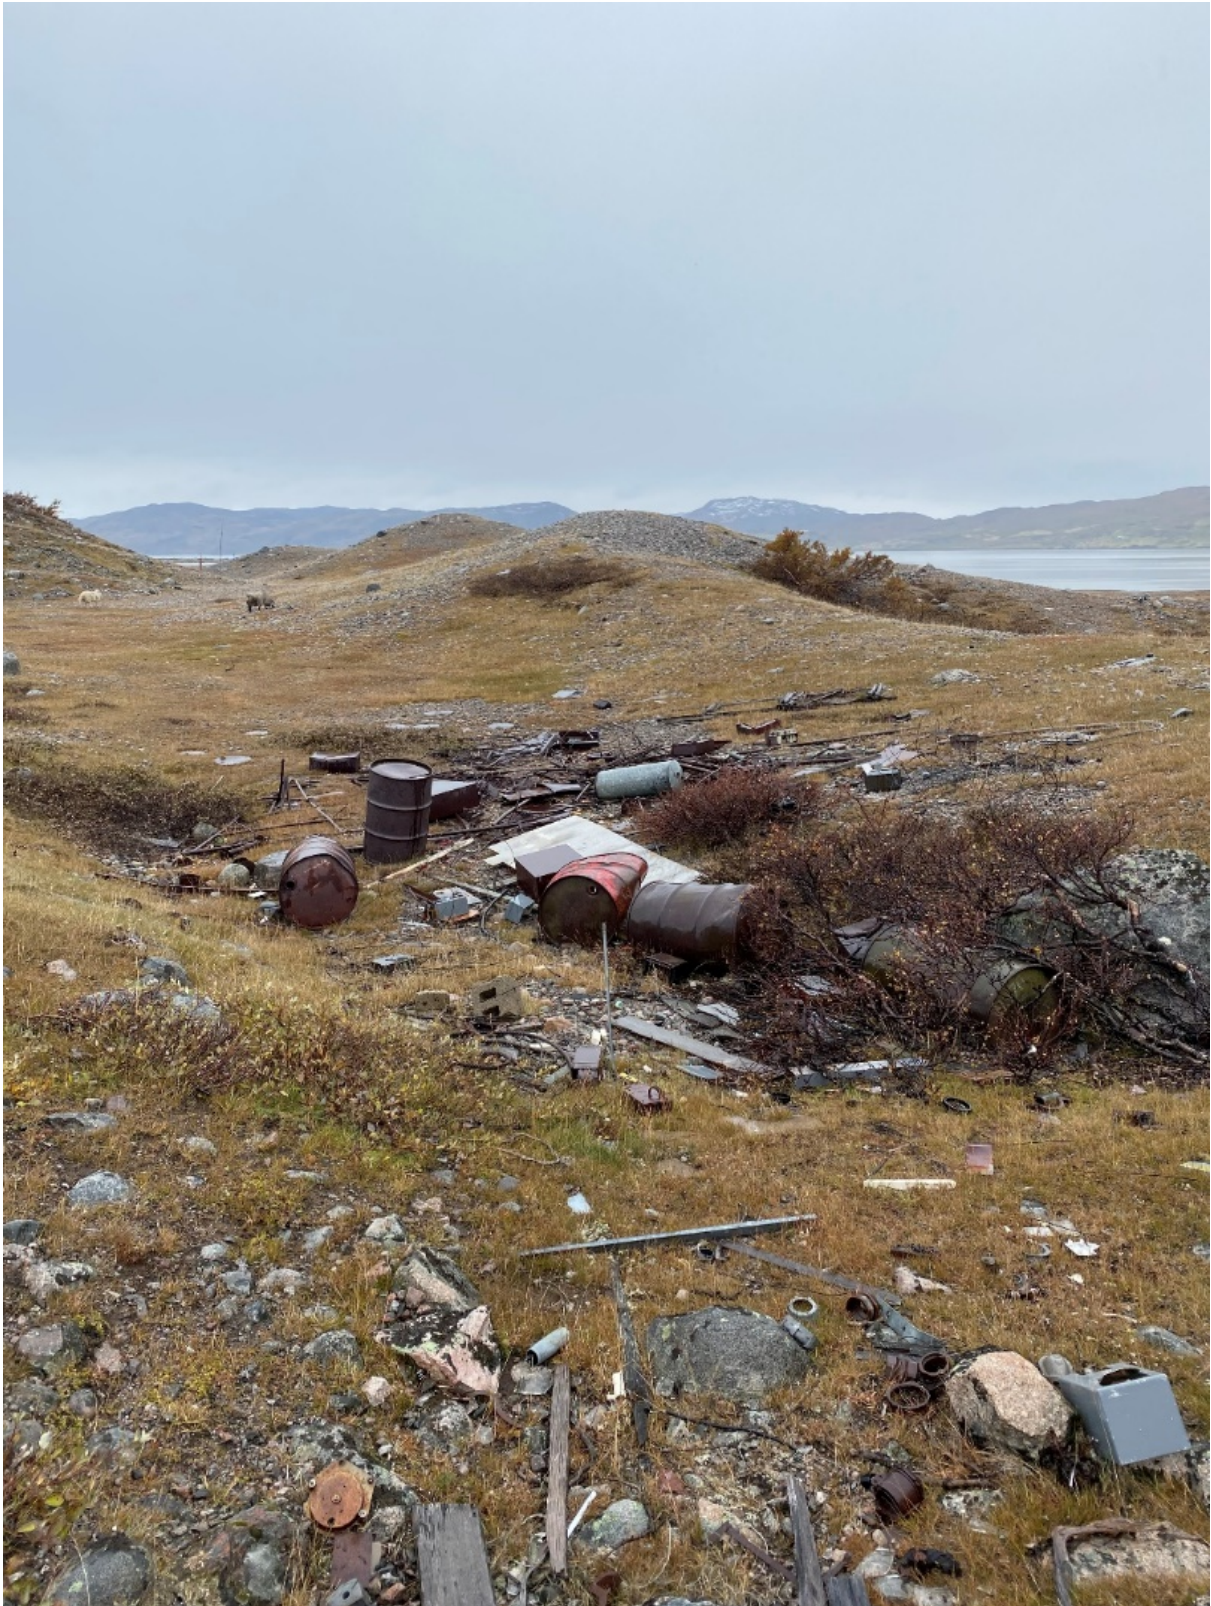
Fig. 117. The smaller of the two American dumps found at Camp Corbett. This dump contained several broken and discarded radio and transmitter components with many still visible maker marks and serial numbers. Photo: Harmsen 2020, facing south.

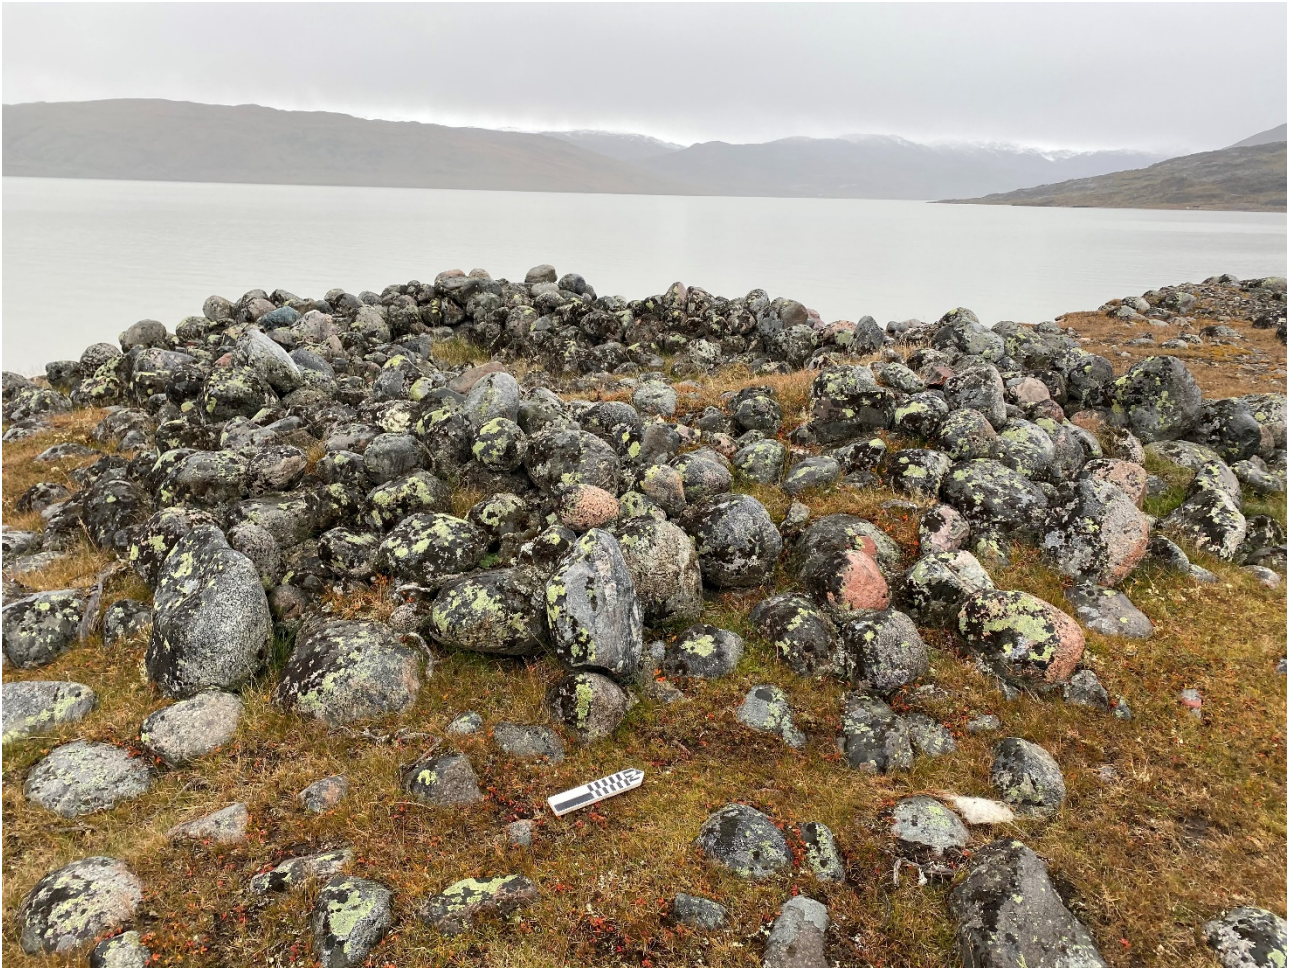
One listed archaeological feature, NKAH 963 (61.17495°, -45.43501°), is found approximately 320 m to the southwest of the sheep stables, on the edge of the plain just above the rocky shore of the Tunulluarfik fjord (Fig. 118). The feature's architecture is a typical of a medieval Norse drying house and was first reported in 1958 by Ancker Weidick. The structure is composed of round piled cobbles and covers an area of approximately 38 m² (Fig. 119). The shape is slightly piriform but generally rounded with no distinct angles. The feature is generally undisturbed and in good condition—surprising given how much human disturbance has taken place in the immediately surrounding area during the American period. Several other piles of large boulders and cobbles are found in the area surrounding NKAH 963, which may have been other features connected to a larger settlement area. All these stones display evidence of modern disturbances and relocation through bulldozing and are not indicative in situ archaeological remains. However, as mentioned above, the drying house lies directly on the edge of an eroding slope (Fig. 120). NKAH 963's proximity to the shoreline places it at future risk of damage from tidal action and storm surges (Fig. 121).

Fig. 119. NKAH 963, Norse drying house. Photo: Harmsen 2020, facing north.

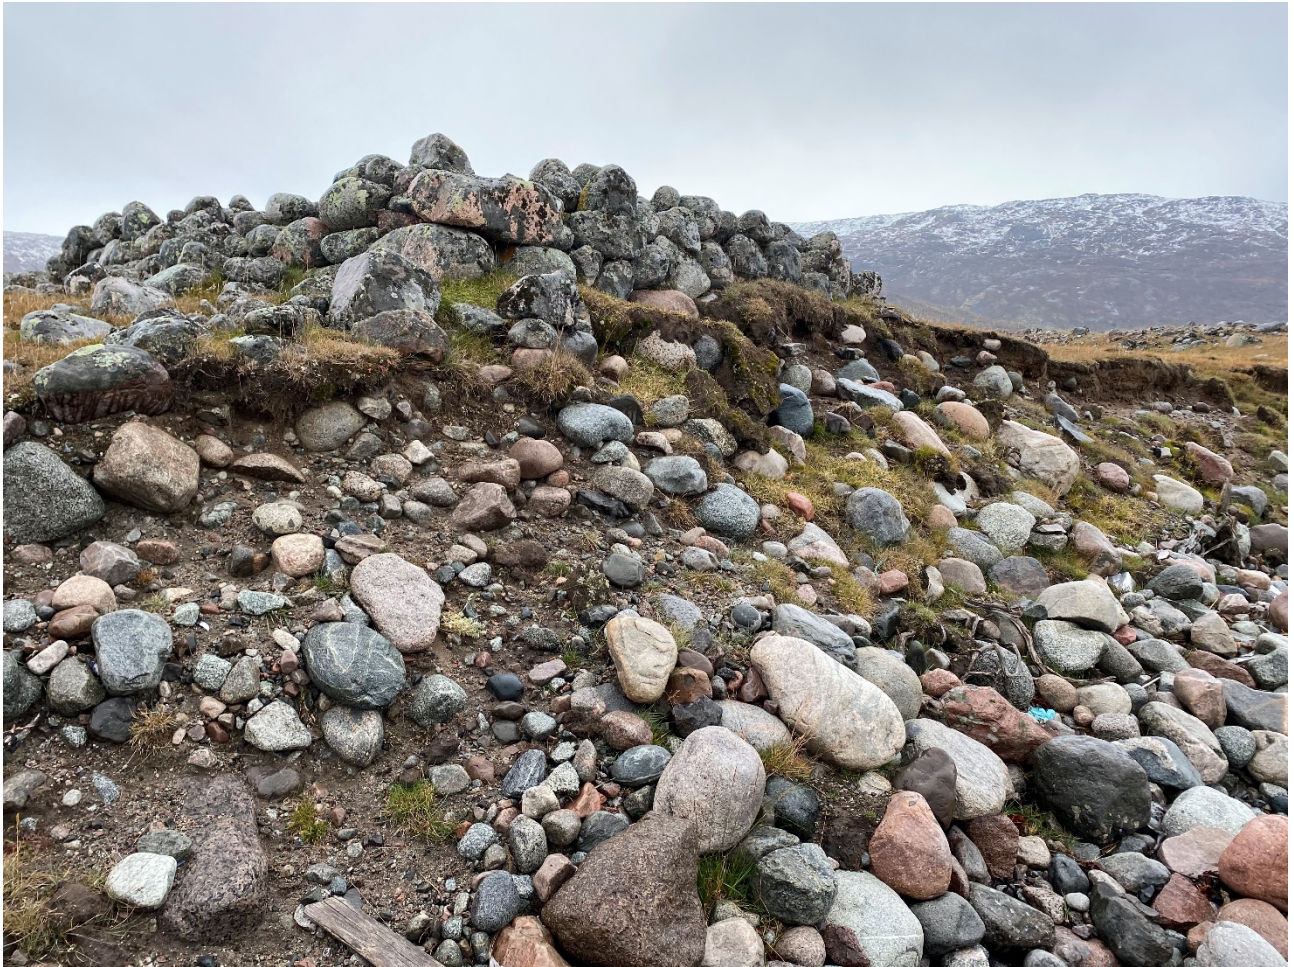
Fig. 121. NKAH 963, facing east from the beach. The feature lies above an active erosion zone where evidence of recent movement can be observed by the exposure of subsoil. The feature's close proximity to the shoreline places it at risk from tidal action and storm surges. Photo: Harmsen 2020.

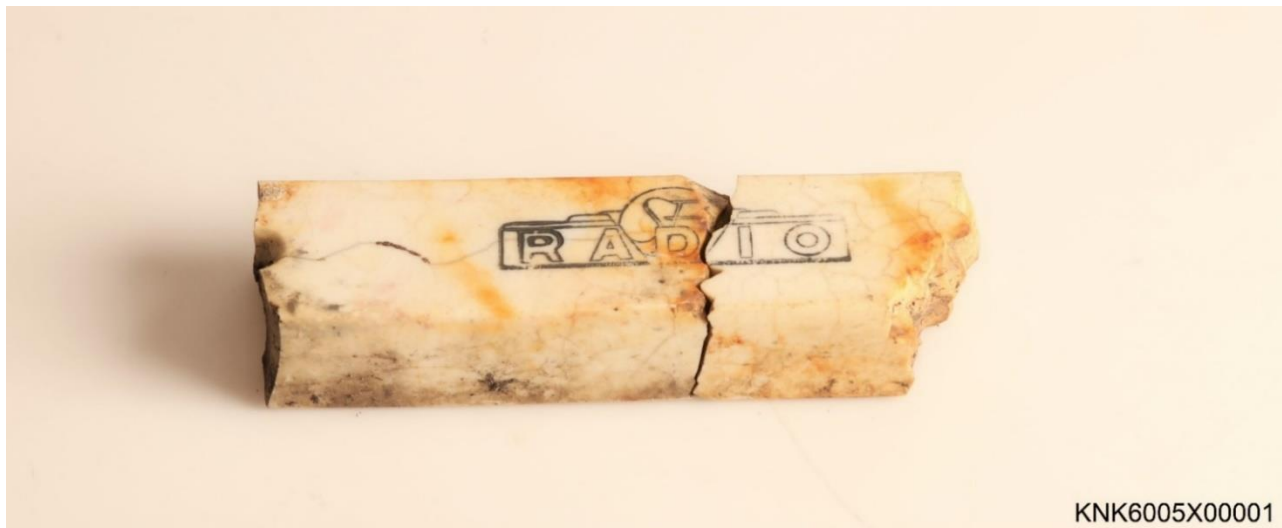
KNK6005X00001

Objektet er en hvid porcelænsisolator med en aflang, firkantet form. Isolatoren er knækket på midten og der mangler et stykke yderst til højre, som fremtræder ituslået. I venstre side kan det anes hvor isolatoren en gang har været fastgjort til en wire. Her mangler ligeledes yderstykket, dog fremgår halvdelen af hullet til wiren endnu. Med sort skrift ses teksten "SF RADIO", der er centreret på oversiden af isolatoren.

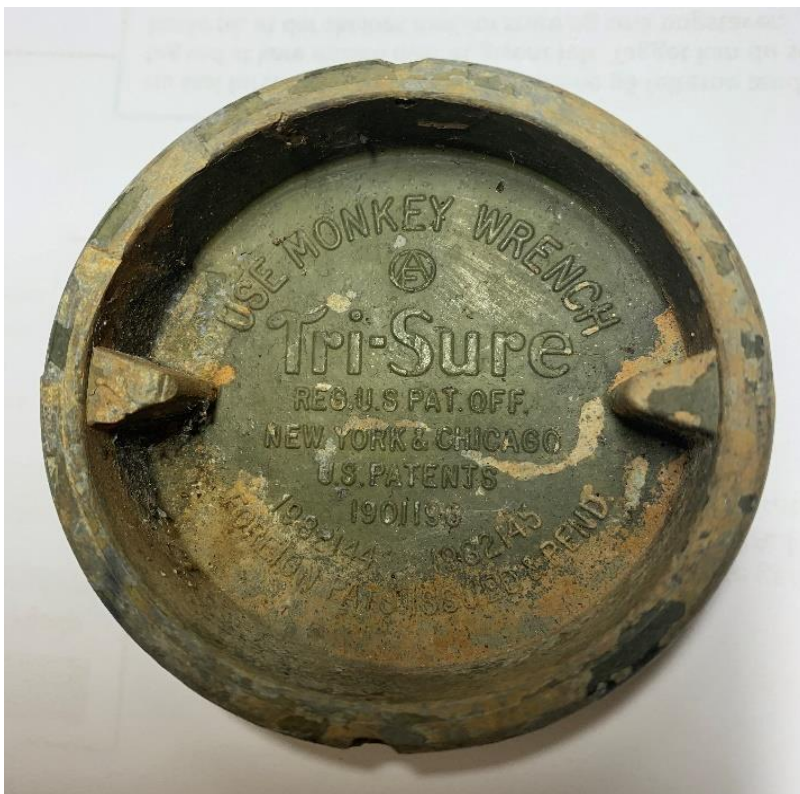
Nærbillede af KNK6005X00003

Objektet er en grøn, rund metalkapsel med gevind. Inde i kapslen fremgår teksten,

"USE MONKEY WRENCH, Tri-Sure, REG.U.S PAT. OFF., NEW YORK & CHICAGO, U.S. PATENTS, 1901198, 1982I44, 1982I45, FOREIGN PATS. ISSUED & PEND."

Kapslen blev anvendt som lukkemekanisme i olietønder og fik navnet "Tri-Sure closure system". Kapslen blev udviklet i USA i starten af 1920'erne af virksomheden American Flange. American Flange blev etableret i 1921 i Chicago og har siden dengang produceret industrielle lukningssystemer og emballage.⁷

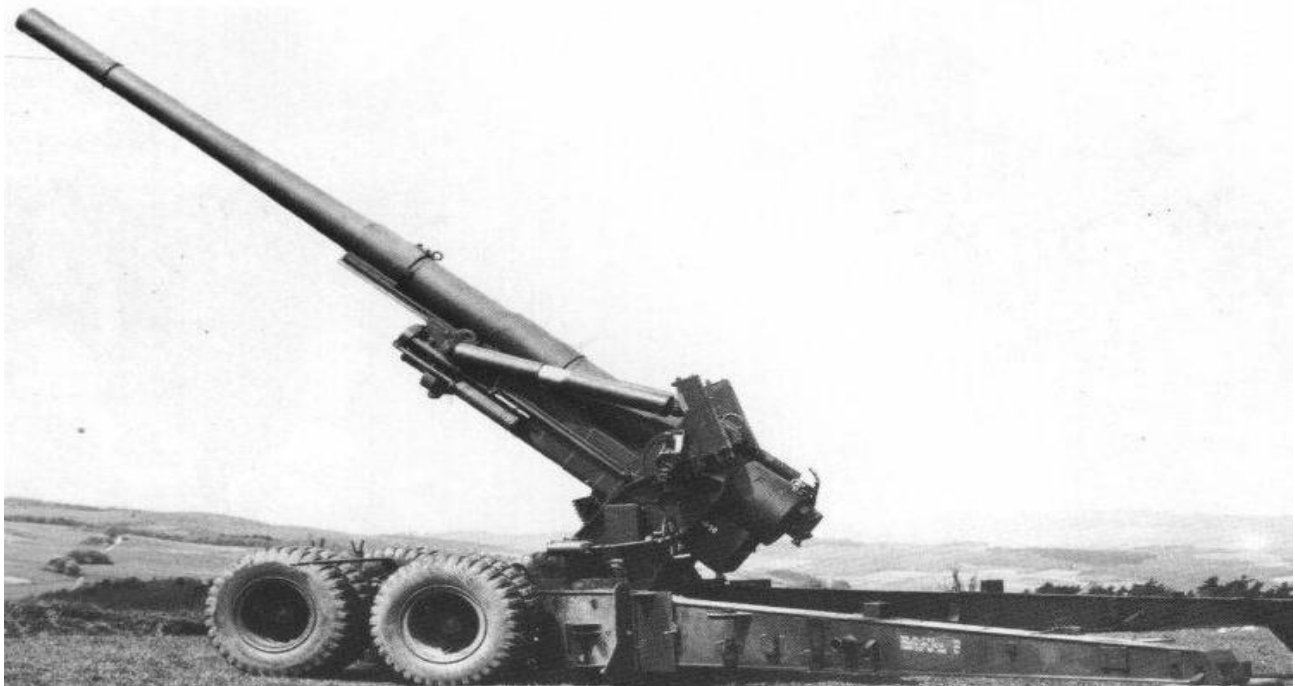
Batterierne på Artillery Point har formentlig været af typen 'M2 155mm "Long Tom" Field Gun', som blev produceret til det amerikanske militær og var hyppigt anvendt blandt de allierede under Anden Verdenskrig. Batteriet blev benyttet til kystforsvar, da det havde en rækkevidde på 24 kilometer. Fotoet er kopieret fra <http://2iemequerre.ca/blindes/longtom.htm>, set d. 11.03.21

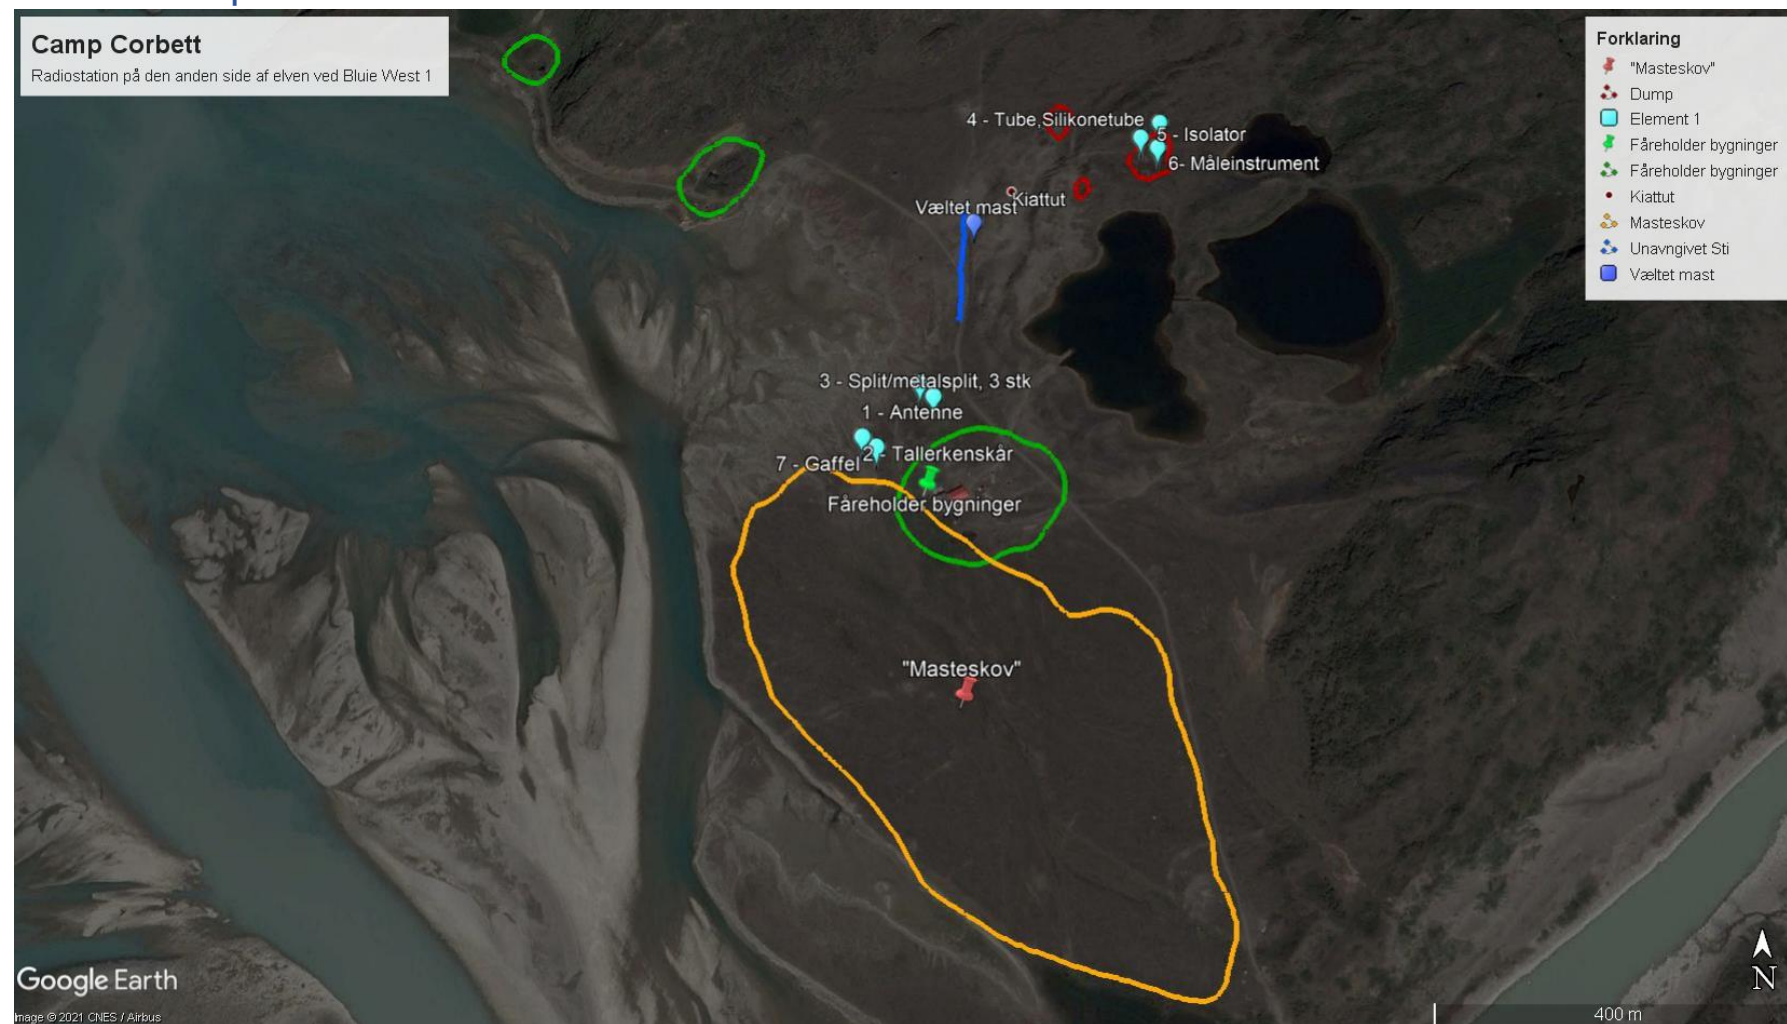
Figur 3 Luftfoto over radiostationen Camp Corbett med påførte markeringer

På figur 3 fremgår tre røde markeringer af dumpe, som blev undersøgte under besigtigelsen af Camp Corbett. På den største af de tre dumpe blev flere af objekterne fra radiostationen indsamlet. De indsamlede objekter er pindet ud med lyseblå markører på kortet. Det var overvejende elektronisk udstyr som optrådte på dumpene, hvilket ligeledes gjorde sig gældende på Blue West 3. Det har efterfølgende været muligt at identificere flere af objekternes oprindelse og produktion til USA, hvilket underbygger amerikanernes tilstedeværelse samt at det fortsat i dag er muligt at finde spor fra deres tid på basen.
