ARCHAEOLOGICAL SURVEY OF BLUIE WEST 3, GAMATRON, ARTILLERY POINT AND CAMP CORBETT, KUJALLEQ KOMMUNE, SOUTH GREENLAND, 18-25 SEPTEMBER 2020

Report prepared by:

May 2021, Nuuk

Nunatta Katersugaasivia Allagaateqarfialu // Greenland National Museum and Archives

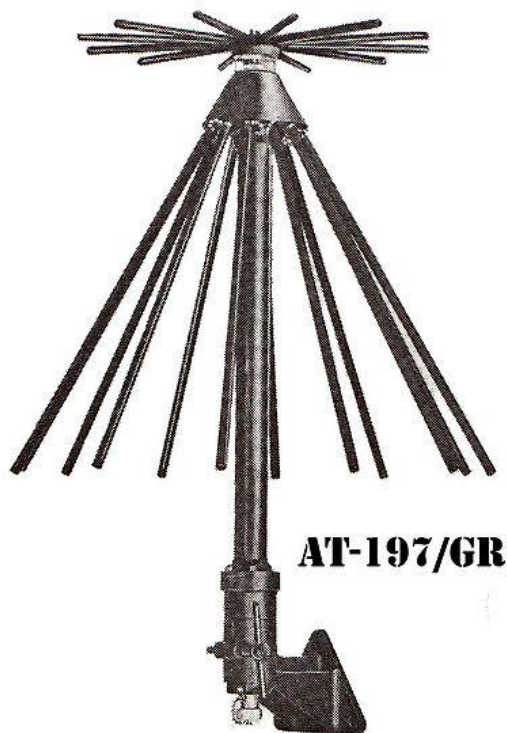
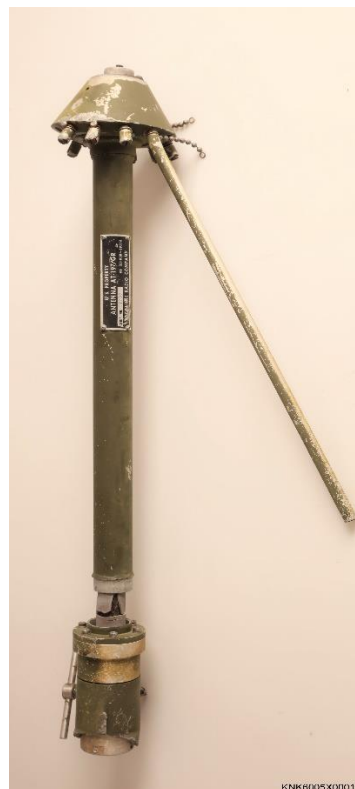
KNK6005X00012 – Antenne

Objektet er en grøn antenne, der er beregnet til at blive monteret på jorden. Antennen har oprindeligt haft en top med 12 antennearme, formet som en cirkel. Den nedre del af antennen har været en kegleform dannet ud af 12 antennearme, hvorfra blot en arm er at se på objektet i dag. I bunden af antennen ses et håndtag, som har været anvendt til at spænde beslaget, der ville have siddet i bunden af antennes cylinderformede stang.

På objektet fremgår et sort beslag med teksten "U.S. PROPERTY, ANTENNA AT-197/GR, SERIAL NO. 7583, AF 33(038) -19516, COLLINS RADIO COMPANY".

Objektet, KNK6005X00012, Antenne, er indsamlet på basen Camp Corbett. Det var deltagere fra NIRAS og Forsvarsministeriets Ejendomsstyrelse der opdagede objektet og dens position, hvorefter antennen blev indsamlet og registeret af NKA (Fotoet er kopieret fra <https://radionerds.com/index.php/AT-197> - set d. 27.01.21) Til venstre ses en komplet udgave af samme type antenne som KNK6005X00012, der fremgår på fotoet til højre.

Antennen har været anvendt til at kommunikere fra jord til luft. Den er designet til at modtage og afsende signaler i samspil med en radiomodtager/afsender. Derudover har antennen kunne anvendes som vejviser og er designet med omnidirektionelle egenskaber i forhold til udstråling- og afsendelse af signaler.¹³

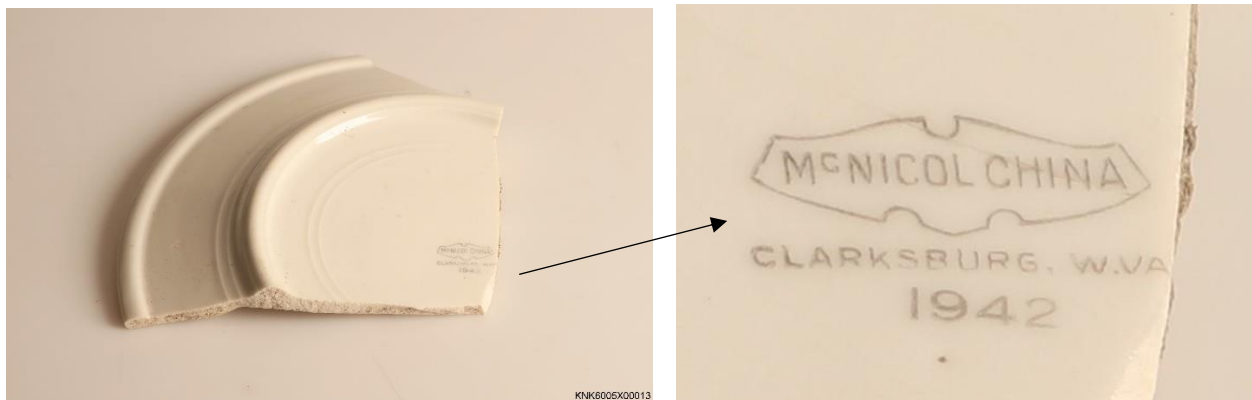
På bagsiden af tallerkenen fremgår et stempel med teksten "McNICOL CHINA, CLARKSBURG, W.VA, 1942". Det vurderes ud fra dette mærke, at objektet med stor sandsynlighed er bragt til Camp Corbett af amerikanerne under Anden Verdenskrig.

Årstallet, 1942, får objektet til tidsmæssigt at falde ind under perioden med amerikanernes tilstedeværelse i Grønland. Derudover fortæller mærket, at objektet er produceret på en amerikansk virksomhed.
